Property Inspection Report

Property Address: Undisclosed

Report Prepared for: Example EIFS Report

Inspection Date: 10/26/2021

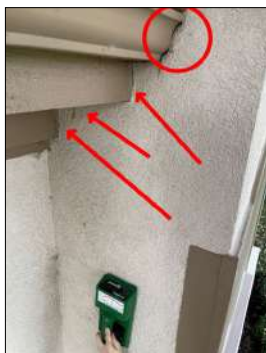
Always maintain sealant around the wood surfaces of the soffits and fascia boards where they actually protrude into the EIFS surfaces. The circle in the picture is that it appears that the basecoat mesh of the EIFS is visible. Requiring the gutter to be removed to seal it up.

1.17. *** I am recommending that every location where the end of the gutter stops against the EIFS Surfaces to be removed to seal up the base coat mesh to prevent water intrusion. This issue was found at every one of these locations except for 2 of the gutters were so tight against the surface that I could not verify but suspect.

1.18. Always maintain sealant around the wood surfaces of the soffits and fascia boards where they actually protrude into the EIFS surfaces.

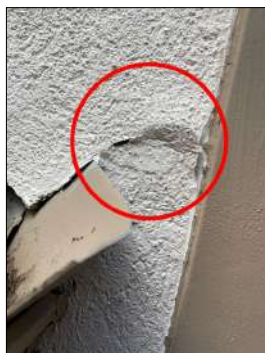
1.3. The EIFS surface is cracked at the kick out flashing on the garage north side next to the dining room window.

The EIFS surface is cracked at the kick out flashing on the garage north side next to the dining room window.

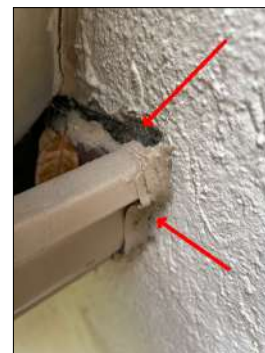
1.4. On the garage north side where the gutter meets the EIFS surface, the exterior top coat surface is missing leaving the interior base coat MESH visible.

On the garage north side where the gutter meets the EIFS surface, the exterior surface is missing leaving the Base Coat MESH is visible.

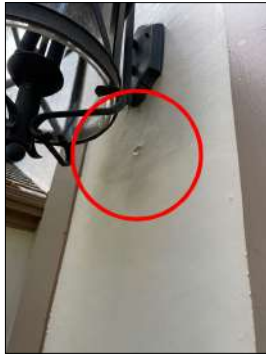
The siding has water damage and needs to be replaced were the front porch light fixtures are attached.

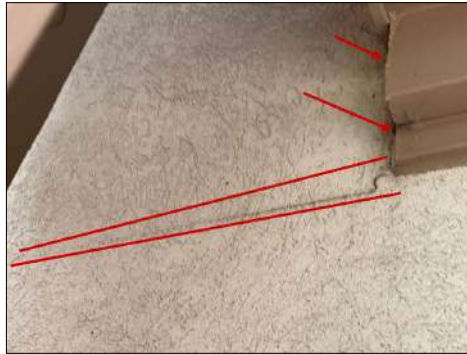
1.6. The EIFS surface at the north side at the front porch has a horizontal crack at the bottom soffit area. No moisture detected surface should be sealed.

The EIFS surface at the north side at the front porch has a horizontal crack at the bottom soffit area. No moisture detected surface should be sealed.

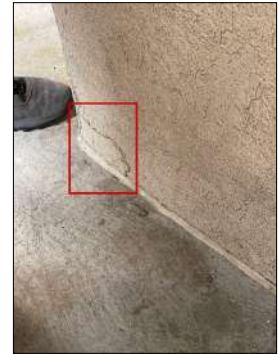
1.7. The EIFS at the front porch north side just above the concrete surface is cracked and should be sealed.

The EIFS at the front porch northside just above the concrete surface is cracked and should be sealed.

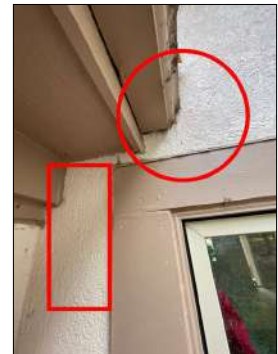
1.8. On the exterior west side of the living room above the north side windows, there is a gutter and there is excessive moisture content at the gutter area and below the soffit proximately 12 feet (basement foundation sill plate).

On the exterior west side of the living room above the north side windows there is a gutter there is excessive moisture content at the gutter area and below the soffit proximately 12 inches.

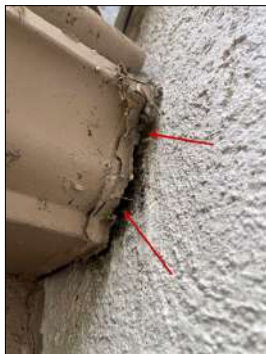
1.9. The EIFS BASE COAT mesh is visible at the end of the gutter above the living room exterior above the North side of the window. This may be where the moisture is getting in behind the surfaces. There was high moisture content all the way down to the basement. There's also evidence of water intrusion and Mold Growth on the interior basement surfaces on the exterior wall sheathing and wall cavity.

The synthetic stucco mesh is visible at the end of the gutter above the living room exterior above the North side of the window. This may be where the moisture is getting in behind the surfaces.

1.10. Once the exterior EIFS is removed at the North side of the Living room windows down towards the basement exterior pedestrian door, then the Plywood Wall Sheathing can be evaluated to see if it needs to be replaced or not.

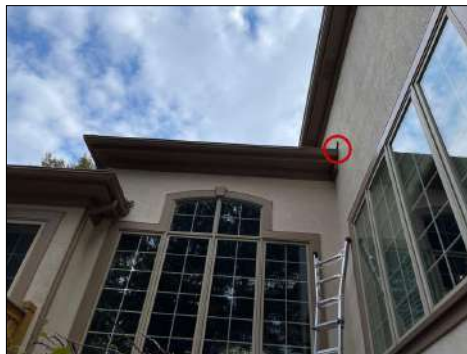
Living room area. West side above the living room south side windows at the gutter running north to south, the kick out flashing was not installed properly and there is visible EIFS Base Coat Mesh at the end of the guttering.

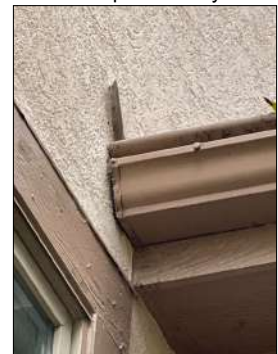
1.12. West side above the air conditioning condensers at the lower gutter running west to east, at the east end of the guttering the EIFS BASE coat Mesh is visible and the kick out flashing was not properly installed.

West side above the air conditioning condensers at the lower gutter running west to east, at the east end of the guttering the synthetic stucco mesh is visible and they kick out flashing was not properly installed.

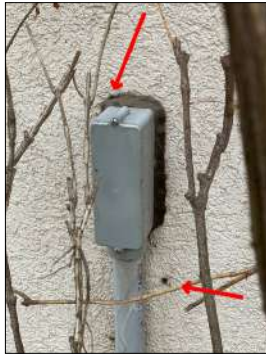
1.13. On the west side south of the air conditioning condensers, there's electrical conduit that needs to be sealed up and there's also screw hole that needs to be sealed.

On the west side south of the air conditioning condensers, there's electrical conduit that needs to be sealed up and there's also screw hole that needs to be sealed.

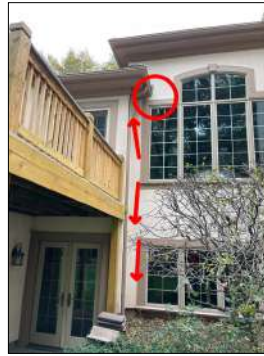
On the exterior west side of the living room above the north side windows, there is a gutter and there is excessive moisture content at the gutter area and below the soffit approximately 12 feet (basement foundation sill plate). The EIFS BASE COAT mesh is visible at the end of the gutter above the living room exterior above the North side of the window. This may be where the moisture is getting in behind the surfaces. There was high moisture content all the way down to the basement. There's also evidence of water intrusion and Mold Growth on the interior basement surfaces on the exterior wall sheathing and wall cavity.

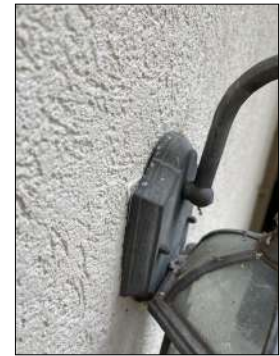
All exterior light fixtures need to be caulked how long the top and sides of the fixtures.

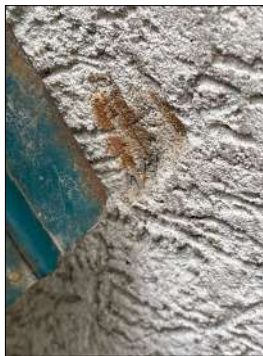
Need to remove the southside garden hose bracket that is attached to the siding. Should not have this attached to the synthetic stucco surfaces and the bracket has also dug into the surfaces.

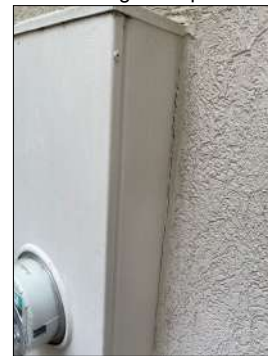
Need to redo the sealant around the exterior electric meter can.

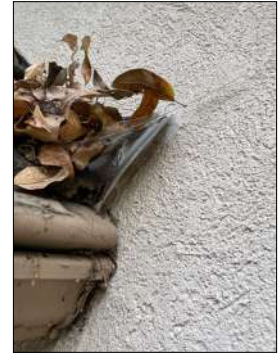
Missing Kick Out Flashing's need to be installed at: Both sides of the garage east bay window area

Missing Kick Out Flashing's need to be installed at: Both sides of the garage east bay window area
There's a kick out flashing on the west side above the north corner of the living room windows that was not properly installed. Since the stucco needs to be cut out there should be a proper kick out flashing installed.

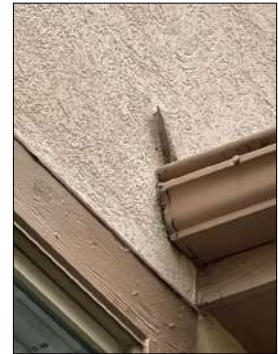
2.5. Improperly installed kick out flashing on the west side above the living room south side

West side above the living room south side windows at the gutter running north to south, the kick out flashing was not installed properly and there is visible EIFS Base Coat Mesh at the end of the guttering.

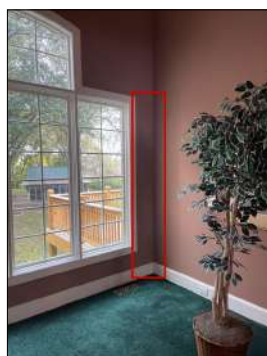
2.1. LR NW corner drywall, baseboard trim and probably wall insulation needs to be removed for mold remediation. Mold growth noted behind the west baseboard trim and baseboard trim is swollen.

LR NW corner drywall, baseboard trim and probably wall insulation needs to be removed for mold remediation. Mold growth noted behind the west baseboard trim and baseboard trim is swollen.

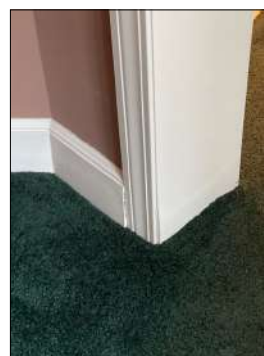
2.2. Doorway between the LR and Kitchen has water damage at the east side door casement trim and both sides at the baseboard trim. Removal needed for mold remediation as needed.

Doorway between the LR and Kitchen has water damage at the east side door casement trim and both sides at the baseboard trim. Removal needed for mold remediation as needed.

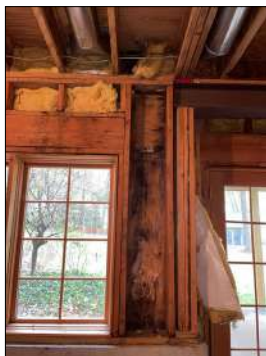
Mold growth is visible in the basement on the exterior wall sheathing at the southside of the exterior pedestrian doors. This is from water intrusion from above the northside living room windows area.

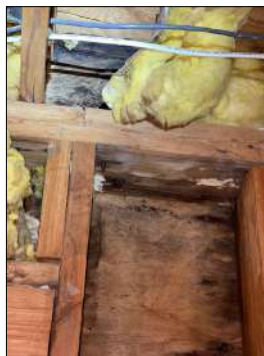
Mold growth is visible in the basement on the exterior wall sheathing at the southside of the exterior pedestrian doors. This is from water intrusion from above the northside living room windows area.

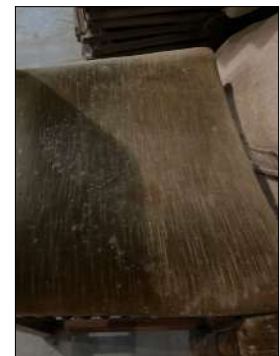
1.7. There is mold growth throughout the basement on furniture and other personal items due to elevated humidity. **** ALL PERSONAL ITEMS IN THE BASEMENT MUST BE REMOVED THROUGH THE EXTERIOR DOOR ONLY!! DO NOT REMOVE ITEMS BY GOING THROUGH THE MAIN LEVEL OTHERWISE MOLD CROSS CONTAMINATION WILL OCCUR.****

There is mold grow throughout the basement on furniture and other personal items due to elevated humidity.

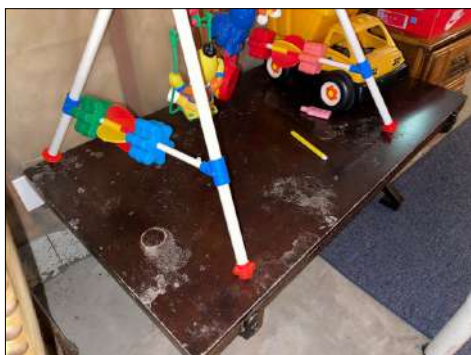
There is mold grow throughout the basement on furniture and other personal items due to elevated humidity.

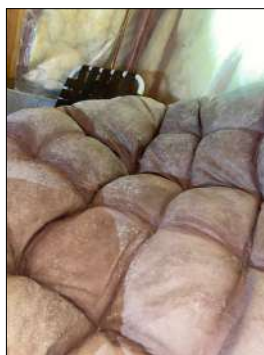
There is mold grow throughout the basement on furniture and other personal items due to elevated humidity.

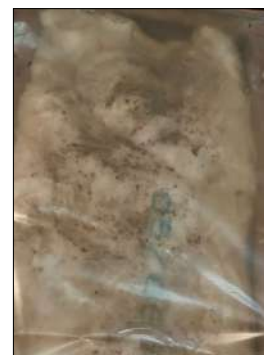
1.8. There is mold growth between the exterior wall insulation and vapor barrier in the basement due to elevated humidity. Remediation and Treatment needed.

There is mold growth between the exterior wall insulation and vapor barrier in the basement due to elevated humidity.

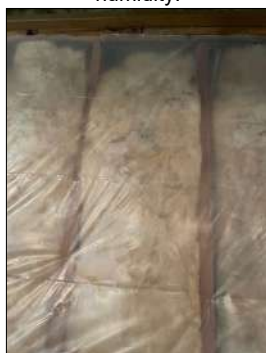
There is mold growth between the exterior wall insulation and vapor barrier in the basement due to elevated humidity.

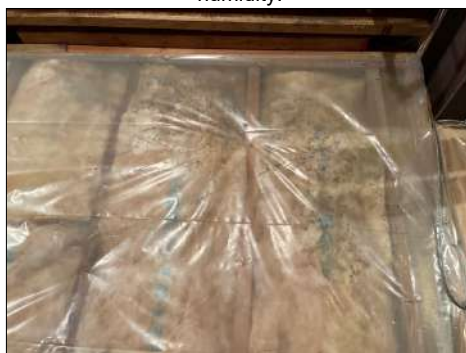
There is mold growth between the exterior wall insulation and vapor barrier in the basement due to elevated humidity.

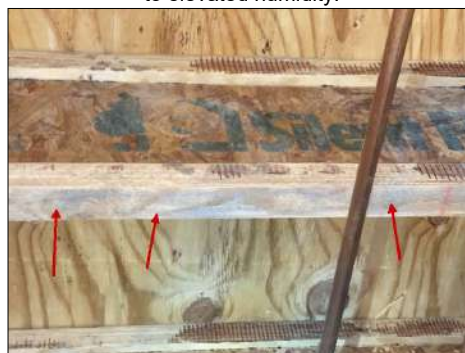
1.5. Visible mold-like growth found on the visible floor joists and or sub-flooring at: White Mold growth on the bottom surfaces of several basement floor joists. Remediation and Treatment needed.

Mold growth along the bottom of several floor joists in the basement

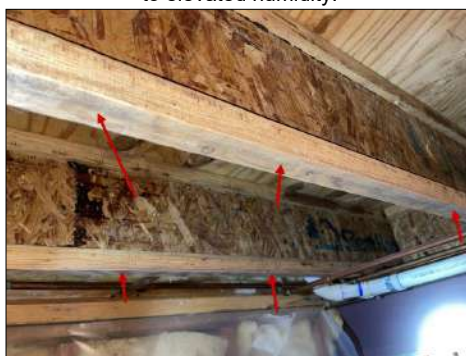
Mold growth along the bottom of several floor joists in the basement
