# RC Certified Inspections

## Property Inspection Report

**Property Address: 119th St.**

**Report Prepared for: Example Commercial Bldg Inspection**

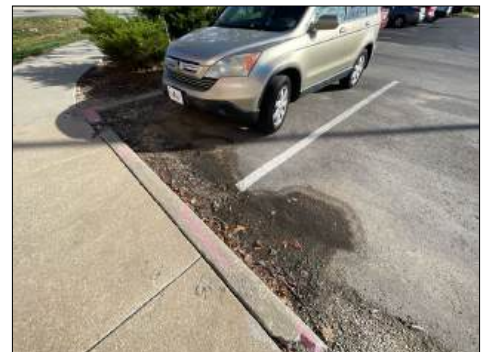
The front concrete curb along the sidewalk is broken up and deteriorated the entire length and needs to be replaced.

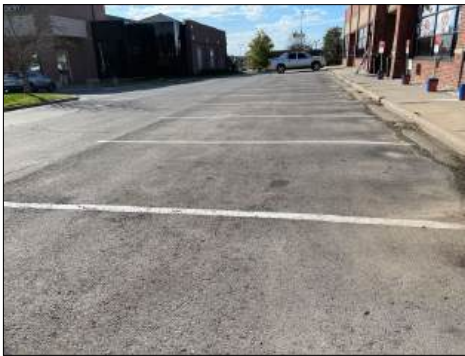
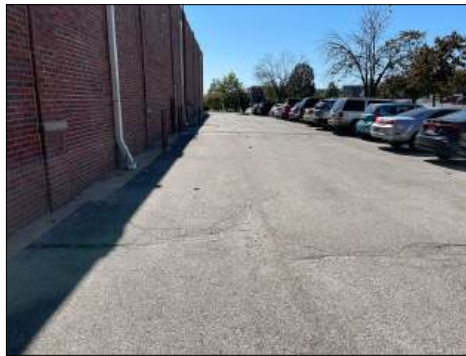
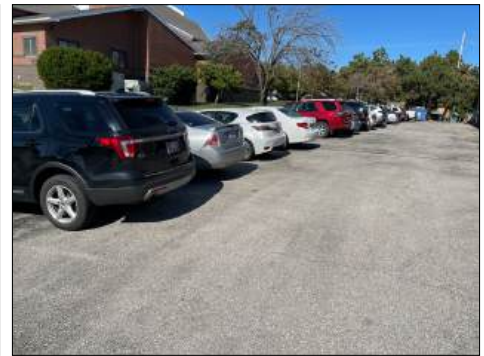
Rear parking Drive area west side towards the south west corner has a large opening in the asphalt that needs to be filled in to help prolong life and prevent tripping hazards.

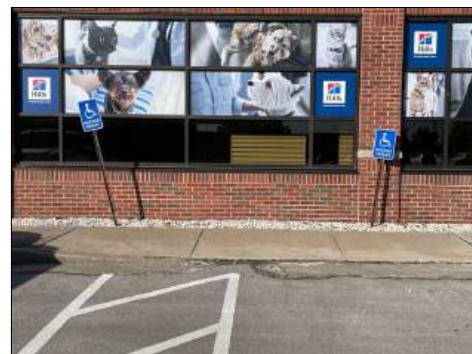
It is recommended that the handicap parking lot striping to be re-striped. They are faded and should be corrected.

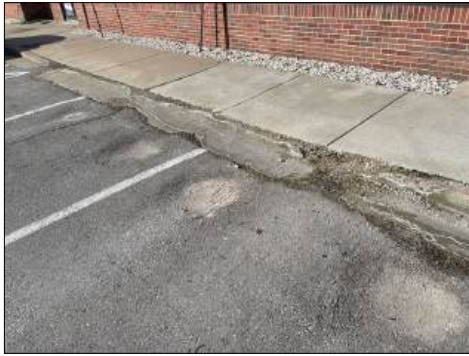
3.1. The sidewalk handicap ramp area is completely deteriorated.

The sidewalk handicap ramp area is completely deteriorated.

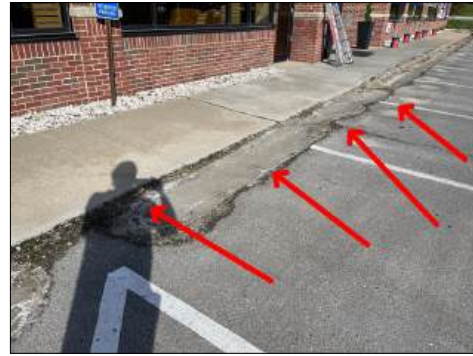
The sidewalk handicap ramp area is completely deteriorated.

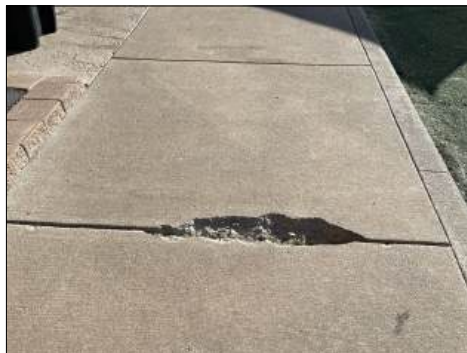
Sidewalk deterioration along the front sidewalk area.

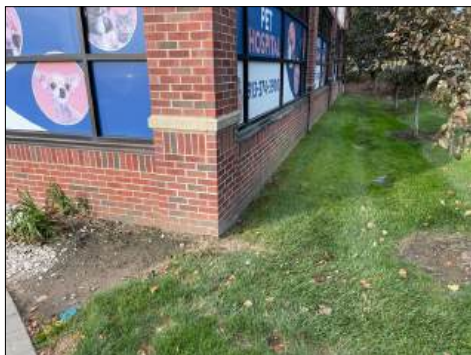
5.3. Soil slope and drainage within 5' of the foundation is Inadequate and needs to be corrected. The soil needs to be sloped and compacted at a 5 degree slope outward from the foundation. This is a 1" drop per foot out to 5', which is equal to a 5" drop at 5' out from the foundation. Keep the soil and ground covering at least 6" below any siding, trim, window openings or foundation vents (where applicable). Negative soil slope towards the foundation can cause foundation damage, basement slab heaving and cracking, water intrusion and mold. Negative soil slope with mulch holds more water against the foundation. This must be corrected and maintained! \*\*

Soil slope and drainage within 5' of the foundation is inadequate and needs to be corrected. The soil needs to be sloped and compacted at a 5 degree slope outward from the foundation. This is a 1" drop per foot out to 5', which is equal to a 5" drop at 5' out from the foundation. Keep the soil and ground covering at least 6" below any siding, trim, window openings or foundation vents (where applicable). Negative soil slope towards the foundation can cause foundation damage, basement slab heaving and cracking, water intrusion and mold. Negative soil slope with mulch holds more water against the foundation. This must be corrected and maintained! \*\*

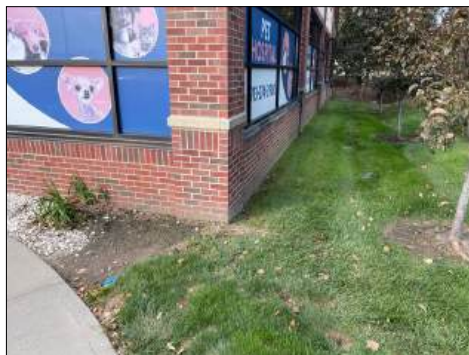
Soil and ground covering must be below the bottom brick surfaces so that water does not become trapped in the brick wall. This is an issue all along the building.

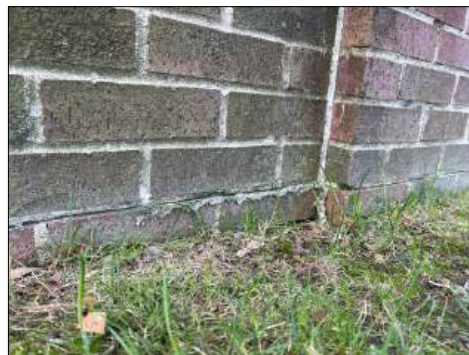
5.6. On the north side of the building where the soil and poor drainage is against the brick and higher than the bottom of the brick, the bottom rows of the brick shows evidence of mortar joint separation. Soil needs to be lowered in the brick mortar joints repaired.

On the north side of the building where the soil and poor drainage is against the brick and higher than the bottom of the brick, the bottom rows of the brick shows evidence of mortar joint separation. Soil needs to be lowered in the brick mortar joints repaired.

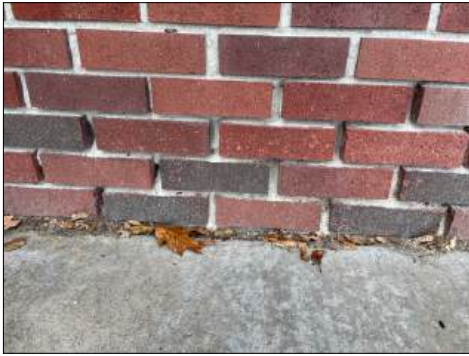
There are several areas of the exterior brick where the mortar is deteriorated and needs to be cleaned up and tuck pointed.

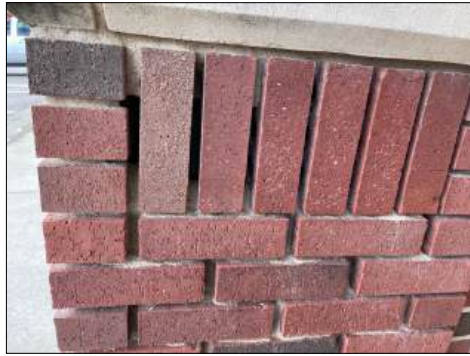
There are several areas of the exterior brick where the mortar is deteriorated and needs to be cleaned up and tuck pointed.

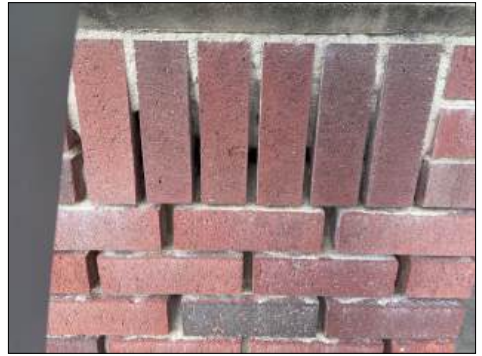
There are several areas of the exterior brick where the mortar is deteriorated and needs to be cleaned up and tuck pointed.

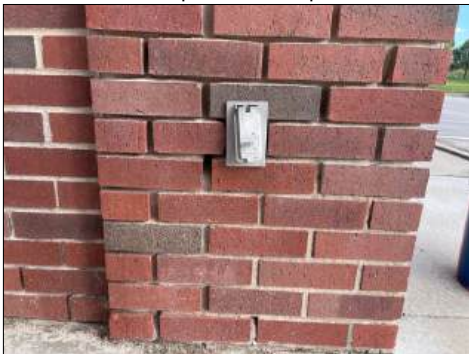
There are several areas of the exterior brick where the mortar is deteriorated and needs to be cleaned up and tuck pointed.

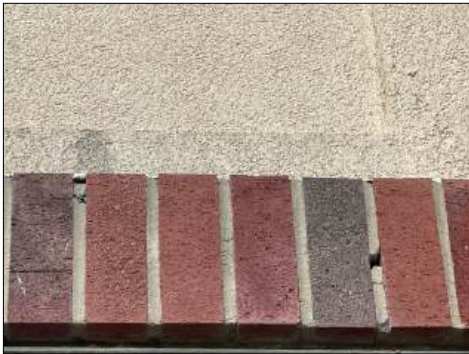
There are several areas of the exterior brick where the mortar is deteriorated and needs to be cleaned up and tuck pointed.

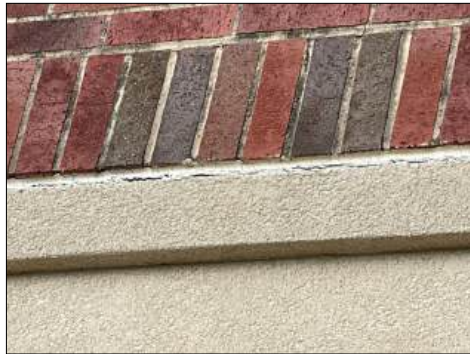
Caulk where Trim meets Siding, Stucco, Brick, Etc.

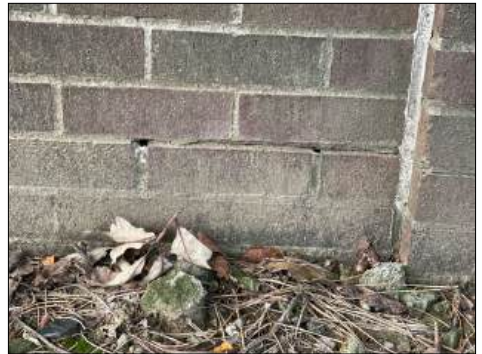
There are several areas of the exterior brick where the mortar is deteriorated and needs to be cleaned up and tuck pointed.

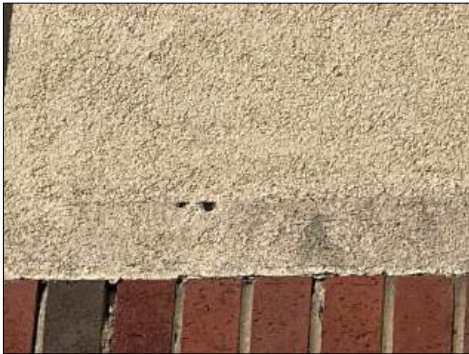
There are areas of the front drivit stucco material That has holes to the surfaces that needs to be repaired. Check all incorrect as needed.

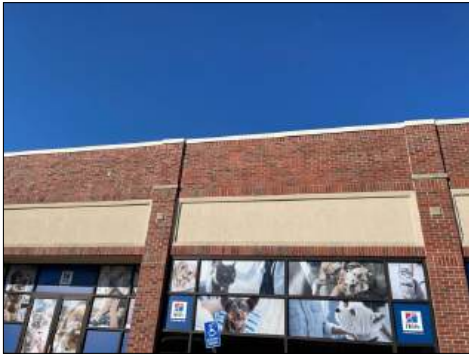
There are areas on the front of building at the upper brick where it looks like there has been signs installed and there are holes in the surface of the brick and mortar that should be sealed or tuck pointed.

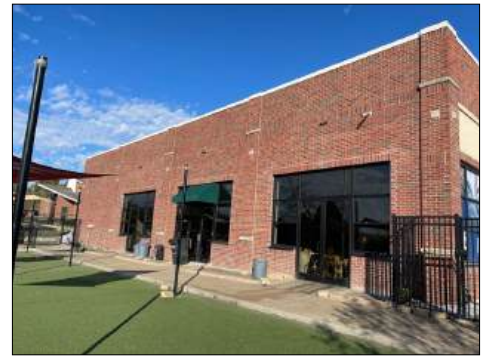
There are a few vertical brick joints that the sealant is deteriorated. Need to clean out these areas and apply new sealant.

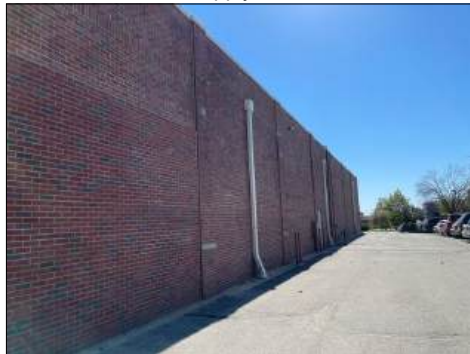
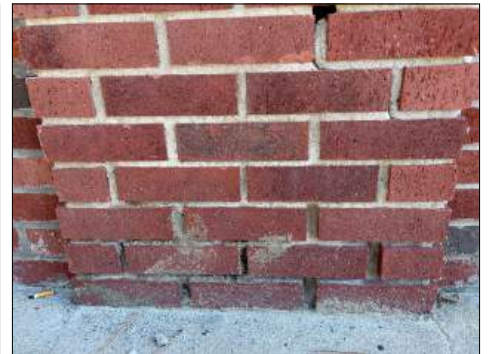
There are several areas of the exterior brick where the mortar is deteriorated and needs to be cleaned up and tuck pointed.

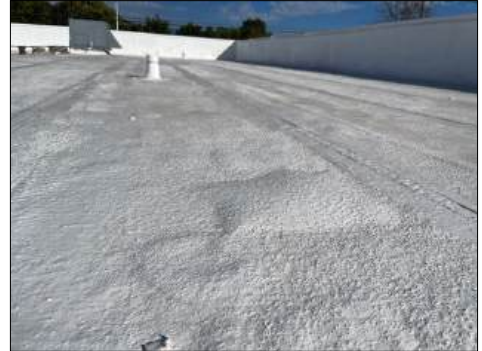
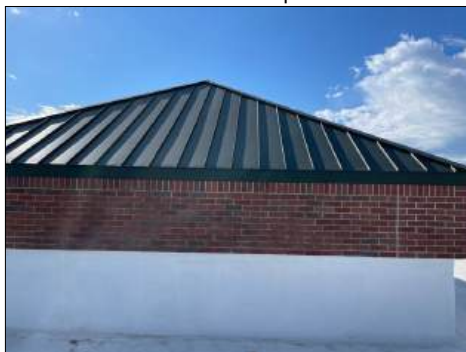
There are a lot of bubbles and wrinkles in this old rolled asphalt material. There are also several areas that it been patched.

2.2. Due to issues with the roof that we discovered, we are recommending having the roof inspected and a bid obtained from a roofing company. Recommend Braden Roofing at 913-341-0200.

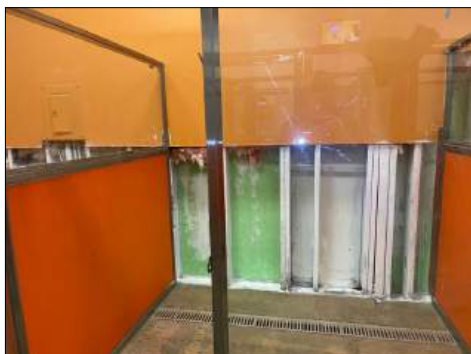
Orange wall mold grow found Above wall cut out where the electric panel is located and the kennel to the north of it.

**growth higher than the lower 4' that was removed. This means the drywall must be cut out higher until 12" of drywall beyond the affected areas have been achieved.**

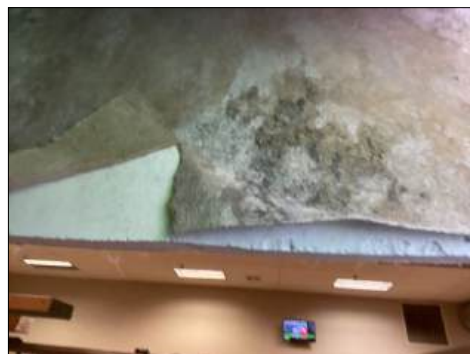
Orange room west wall mold growth above wall cut out at the higher wall cut out areas.

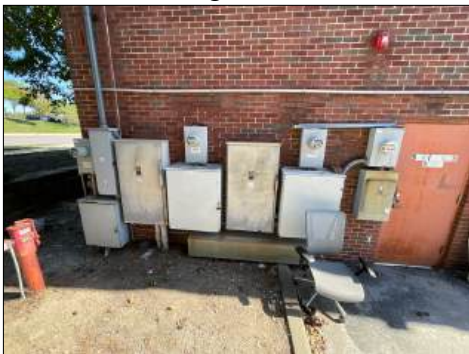
4- Electric Meters, Only 3- Exterior Main Disconnects noted and the South 200amp Disconnect is OFF.

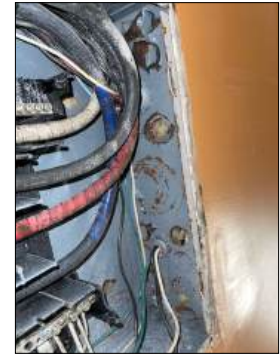
Missing Knockout(s) Plugs need to be installed to keep mice out of panel box and to avoid potential electrocution hazard and to contain any possible sparks or fire from exiting into the wall cavities:  
top of panel

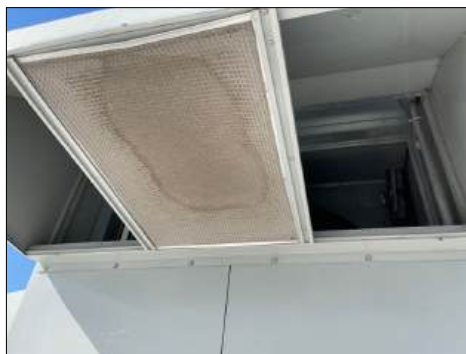
There are three prefilters on the exterior and two of them are missing and the one present is very dirty.

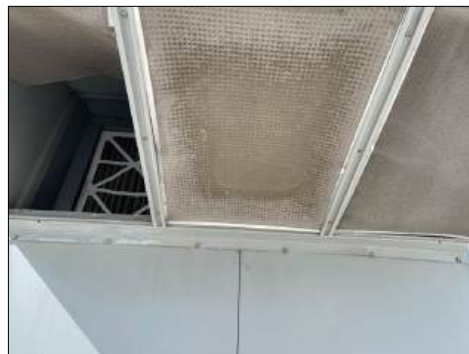
One of the prefilters are missing.

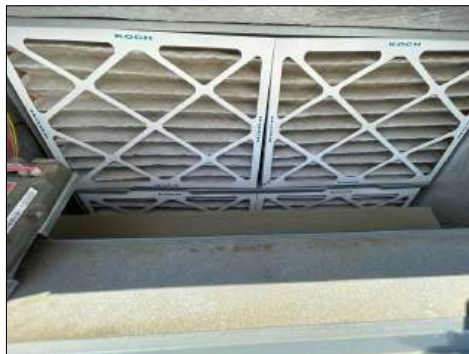
- 4.1. Air filter needs to be replaced now.

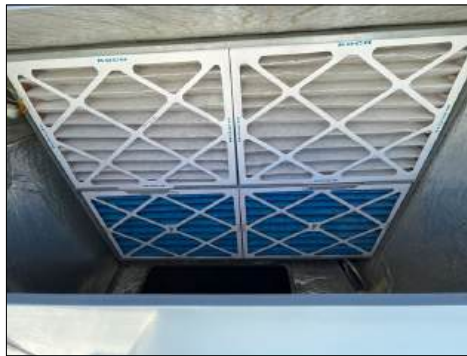
4.1. Air filter needs to be replaced now.

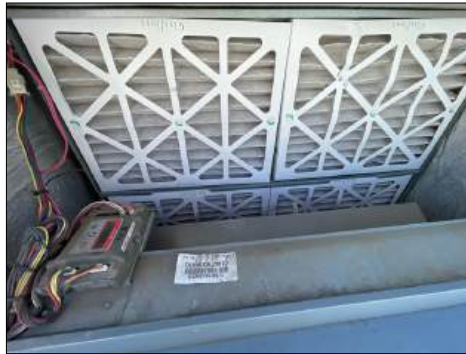
- 4.1. Air filter needs to be replaced now.

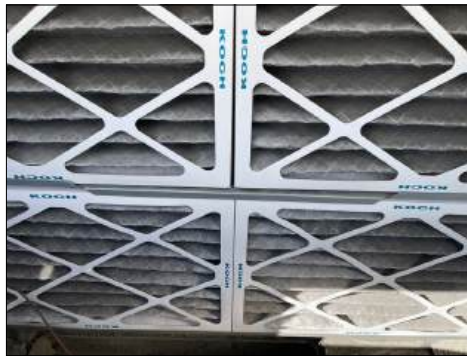
4.1. Air filter needs to be replaced now.

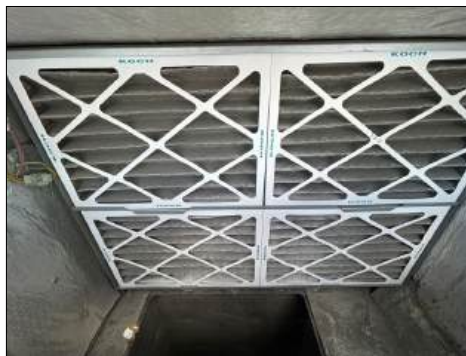
**3.1. Air filter needs to be replaced now.**

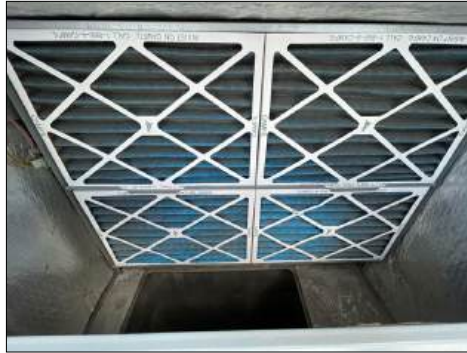
4.1. Air filters Are marked that they were replaced October 16, 2021 but they sure look like they've been in there a lot longer and is recommended to be replaced now.

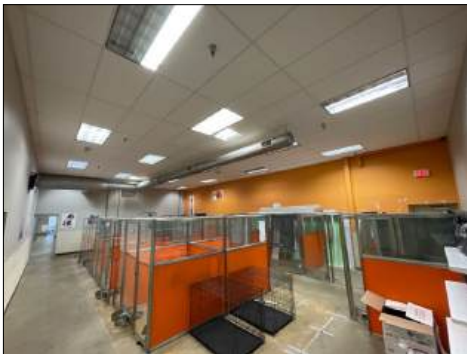
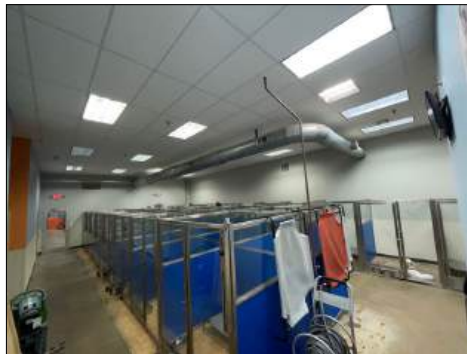
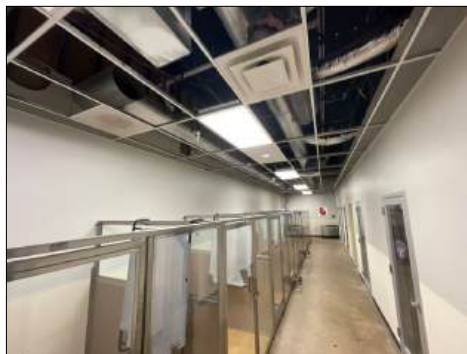
Junction Boxes missing either Cable Connectors, Cover or Knock-Out Plugs at: above west side sw corner room

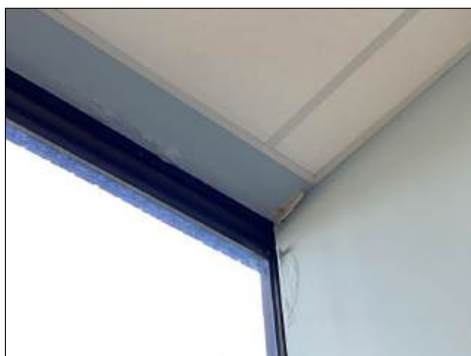
Evidence of water intrusion: above north wall east side windows

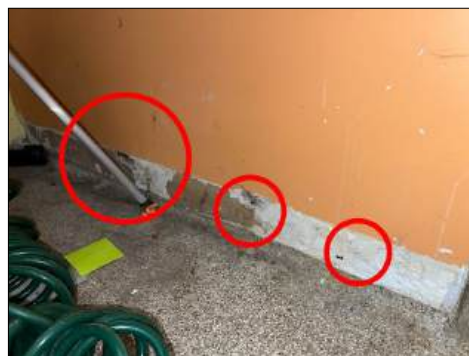
There's brown water staining going down the wall in the north west corner of the Surgery room

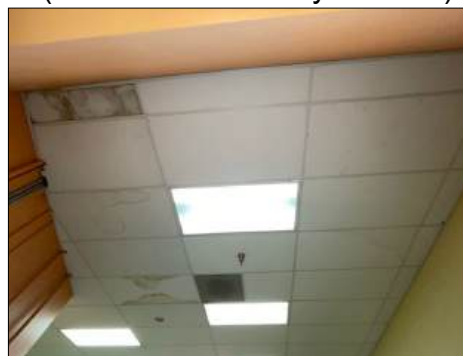
Evidence of Water Stains noted at: above the east door (could be caused by old roof)

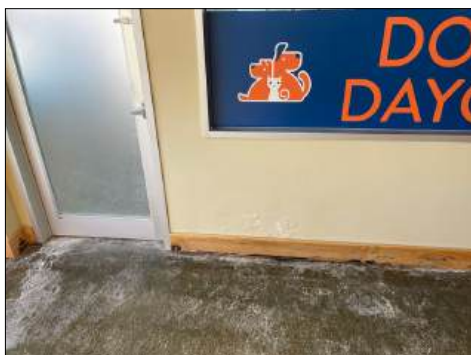
Evidence of a Mold-Like substance present. Mold Testing or Mold Remediation may be required. RC Certified Inspections can provide these services. Also see the MOLD Growth Section in the report. This was found at: along south wall - presumably due to dog pee

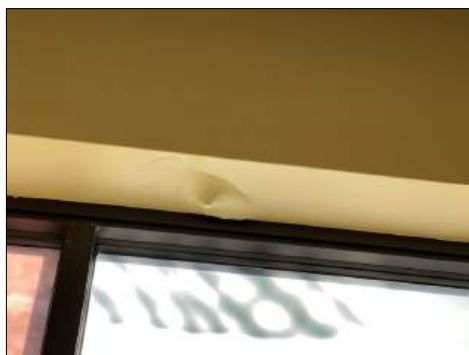
Damaged wall due to water intrusion: North side above the east wall south set of windows

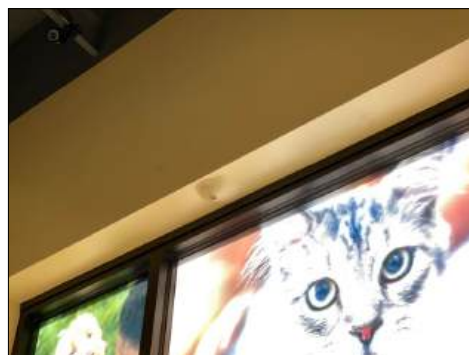
Damaged wall due to water intrusion: North side above the east wall north set of windows

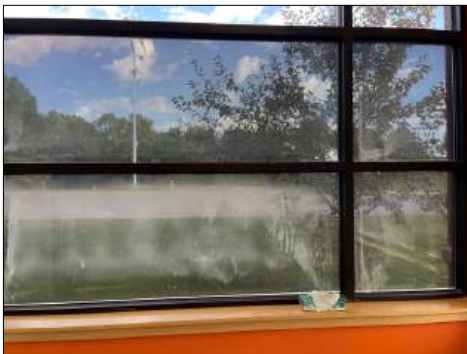
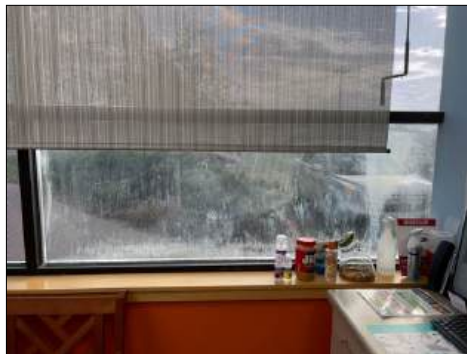
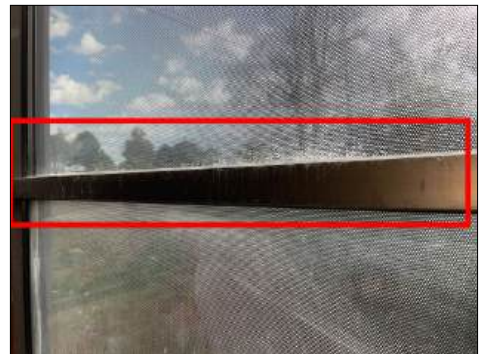
The Window Thermal Pane Integrity shows evidence of failure. The window panes have fogging and condensation between them. They can build enough condensation between the panes to rust through and cause water intrusion into the wall cavity. Recommend further evaluation for needed replacement. Approximately 9 defective windows in the 3 exam rooms

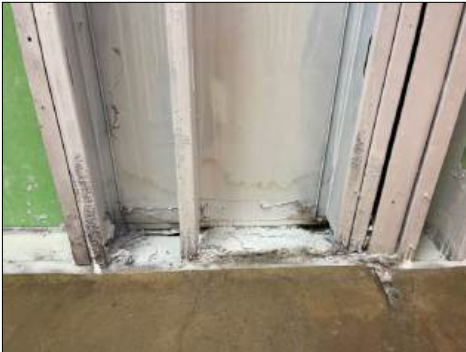
west wall in the north boarding room has water staining at the floor along the white painted walls

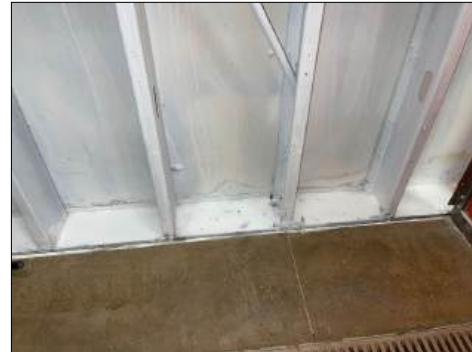
Evidence of a Mold-Like substance present. Mold Testing or Mold Remediation may be required. RC Certified Inspections can provide these services. Also see the MOLD Growth Section in the report. This was found at: found in north boarding room west white walls along floor

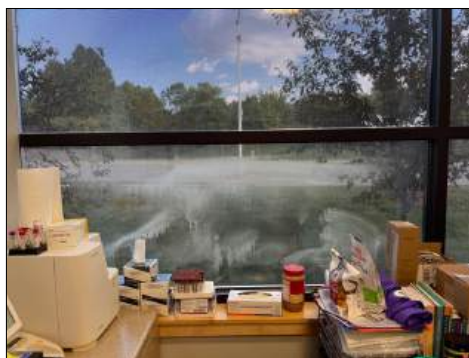
The Window Thermal Pane Integrity shows evidence of failure. The window panes have fogging and condensation between them. They can build enough condensation between the panes to rust through and cause water intrusion into the wall cavity. Recommend further evaluation for needed replacement.

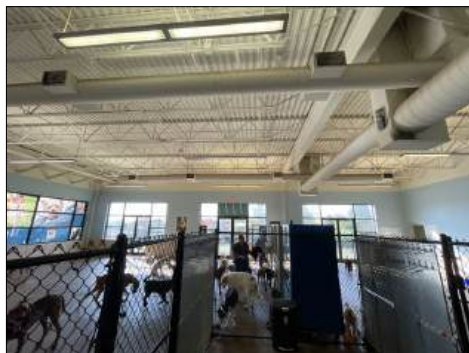
The south interior dog room has two S. side exterior doors without why did exit signs.
