RC Certified Inspections

Property Inspection Report

Property Address: Cedar St.

Inspection Date: 10/27/2021

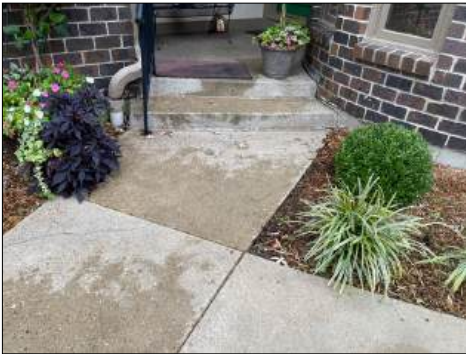
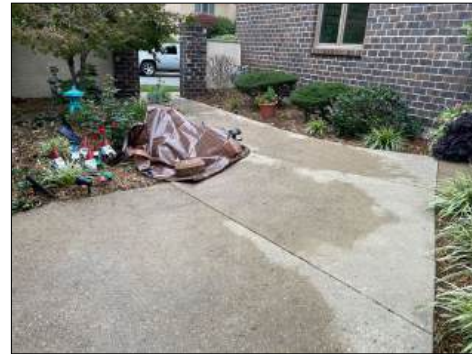
3.1. Typical settlement cracks noted.

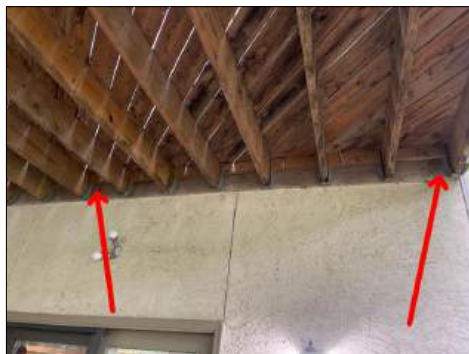
6.2. Joist hangers are missing fasteners were they attached to the sides of the floor Joists. JoistHangers must be installed using either Joist Hanger Nails or #8 or #10 Framing nails. Must have 8 fasteners per hanger. ** This needs to be done at the upper and the lower deck areas.

Joist hangers are missing fasteners were they attached to the sides of the floor Joists. JoistHangers must be installed using either Joist Hanger Nails or #8 or #10 Framing nails. Must have 8 fasteners per hanger.

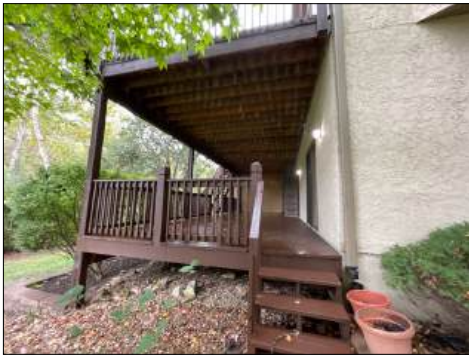
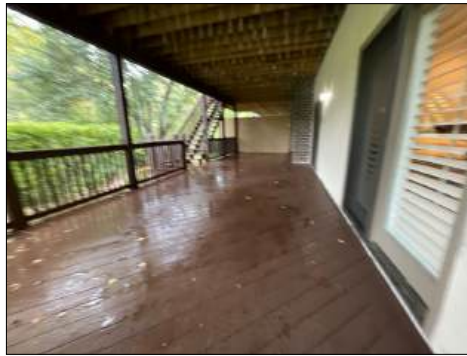
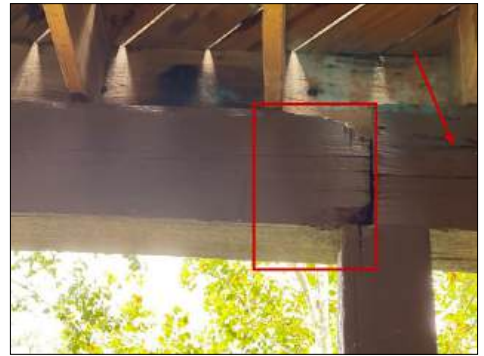
7.8. The upper deck west side Girder/Support Beam has water damage and also evidence of carpenter bees. Due to the height and size of the structure I am recommending further evaluation and possible replacement.

7.9. At the top of the stairs at the riser between the top step in the floorboards has water damage

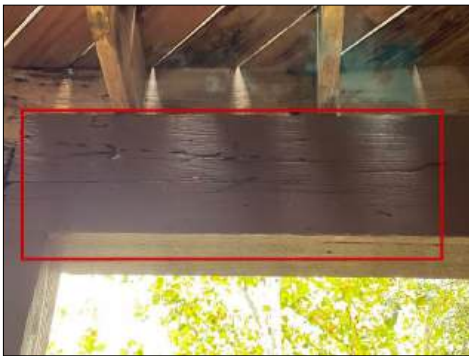
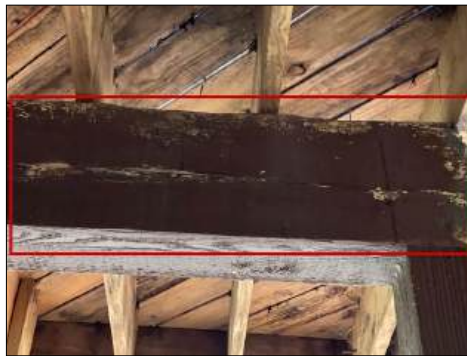
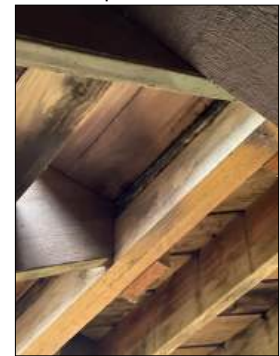
The upper deck west side Girder/Support Beam has water damage and also evidence of carpenter bees. Due to the height and size of the structure I am recommending further evaluation and possible replacement.

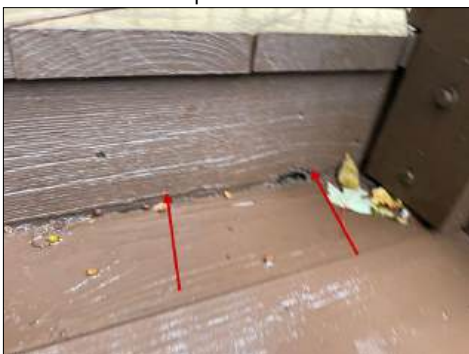
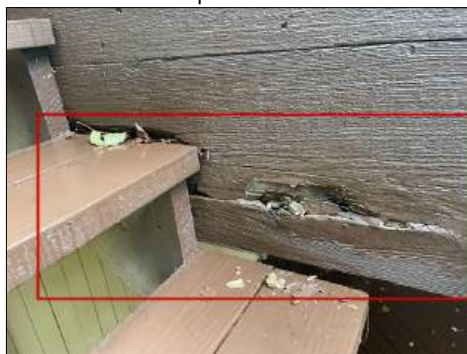
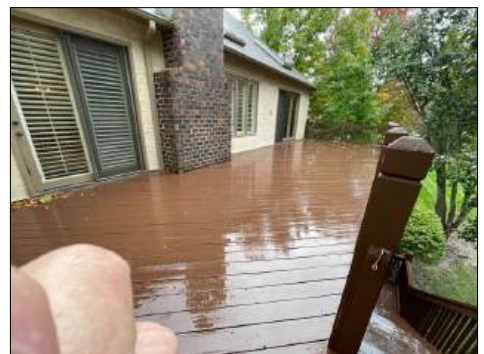
At the top of the stairs at the riser between the top step in the floorboards has water damage

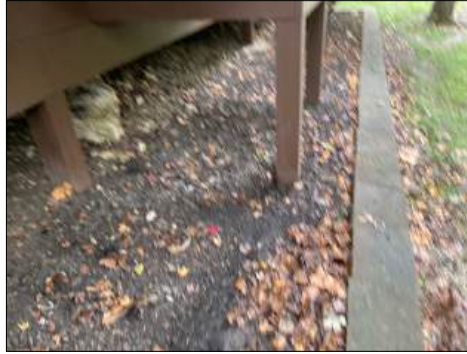
There are deck support posts there are in contact with the soil and needs to be continuously monitored.

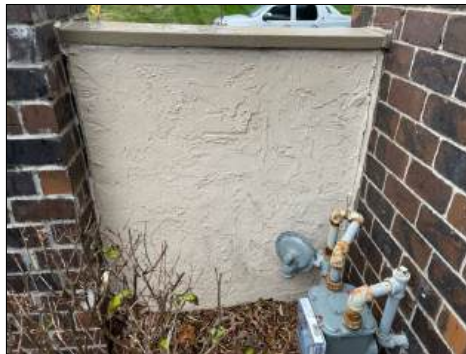
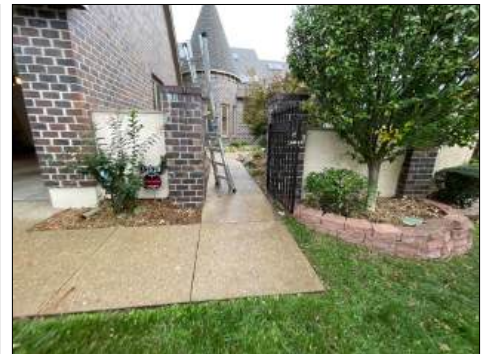
A brick on the north side of the garage at the front porch has a large gap between the brick and the corner trim. This needs to be properly filled in and sealed up. It appears that there are several other areas at the break edges and also needs to be sealed. Need to monitor the brick ledge mortar joints at the windows. They are just starting to open up and will need to be sealed in tuck pointed soon.

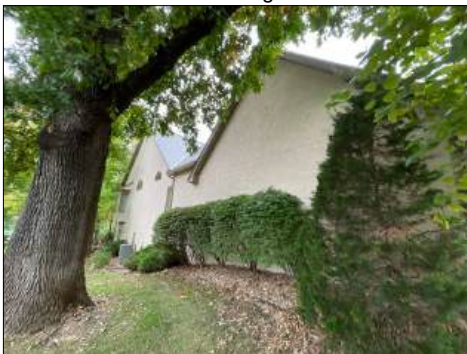
- 1.8. Both sides of the front entry stucco surfaces are loose. They are cracked and opening up at the edges and is in contact with the soil and ground covering.

Both sides of the front entry stucco surfaces are loose. They are cracked and opening up at the edges and is in contact with the soil and ground covering. Both sides of the front entry stucco surfaces are loose. They are cracked and opening up at the edges and is in contact with the soil and ground covering.

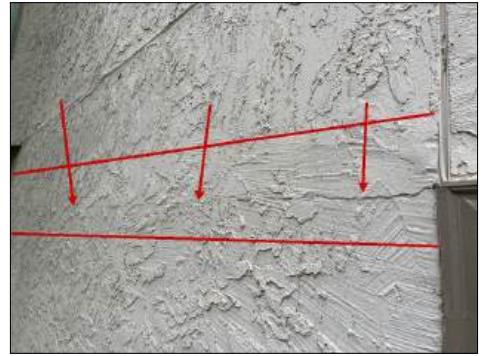
- 1.10. The south side of the Home Stucco surfaces has quite a few vertical cracks but also has a larger horizontal crack at the lower level west of the air conditioning condenser at a window. The smaller cracks can be skim coated Betty horizontal crack appears to have loose material and may need to be removed and replaced.

The south side of the Home Stucco surfaces has quite a few vertical cracks but also has a larger horizontal crack at the lower level west of the air conditioning condenser at a window. The smaller cracks can be skim coated Betty horizontal crack appears to have loose material and may need to be removed and replaced.

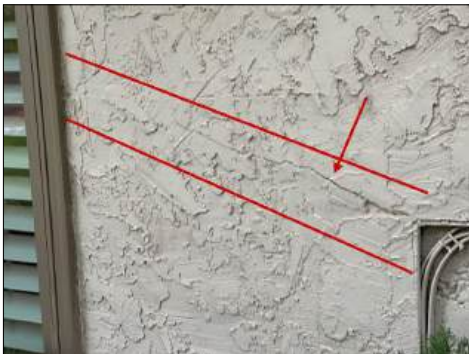
The south side of the Home Stucco surfaces has quite a few vertical cracks but also has a larger horizontal crack at the lower level west of the air conditioning condenser at a window. The smaller cracks can be skim coated but the horizontal crack appears to have loose material and may need to be removed and replaced.

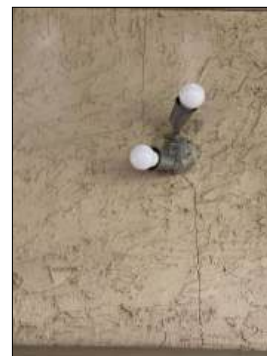
Caulk around the exterior light fixtures.

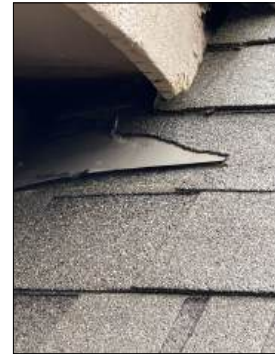
3.8. There is a shingle tab lying in the gutter above the kitchen roof area. It appears to have broken loose below the gutter area where there's flashing located.

There is a shingle tab lying in the gutter above the kitchen roof area. It appears to have broken loose below the gutter area where there's flashing located.

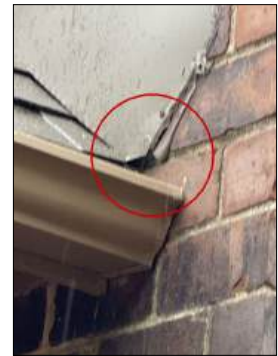
3.9. Missing roof kick out flashing on the west side at the north end of the gutter north of the chimney area. ** Braden Roofing **

Missing roof kick out flashing on the west side at the north end of the gutter north of the chimney area.

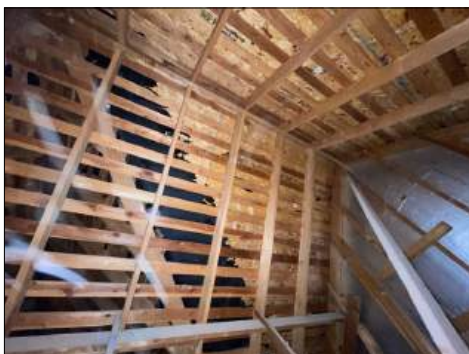
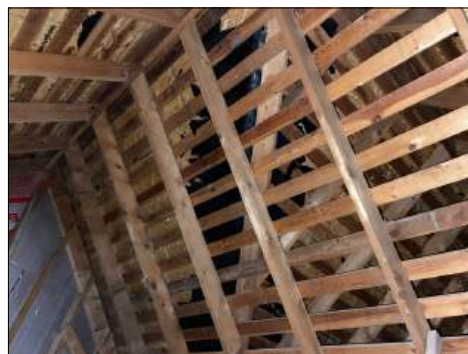
9.2. There aren't any roof vents installed. There should be 1-Sq. Ft. (1-Vent) per every 150 Sq. Ft. of Attic Flooring (Ceiling surface under attic space). Recommend further evaluation and correction. ** Garage Recommend 2.**

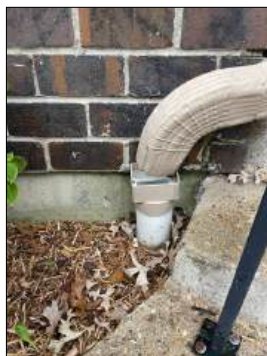
14.5. The far south west corner downspout has become disconnected from the underground drain pipe and is dumping water against the foundation. There should be a reducer that extends down into the underground pipe at least 8 inches to prevent this. The downspout should never be securely attached to the underground pipe.

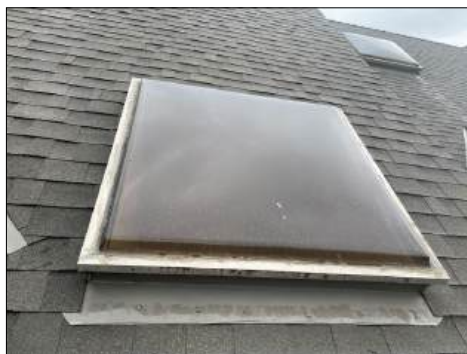
15.1. The Skylight(s) appear to beyond their life expectancy. Recommend replacement. MONITOR

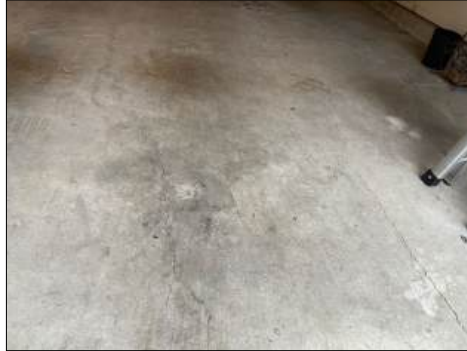
9.1. Typical concrete floor settlement cracks.

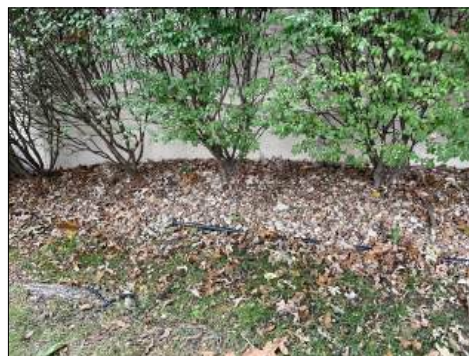
The southside foundation at the garage area has a couple of cracks which appear to be having some movement. The drainage is extremely bad along the side which causes issues with the foundation.

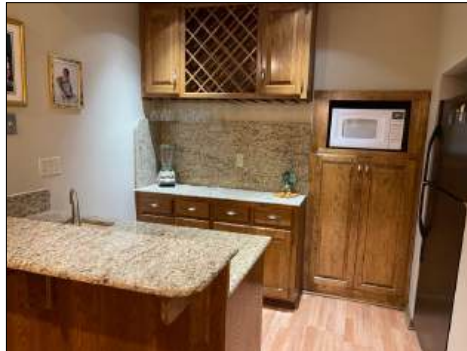
8.1. Garbage disposal is not operating

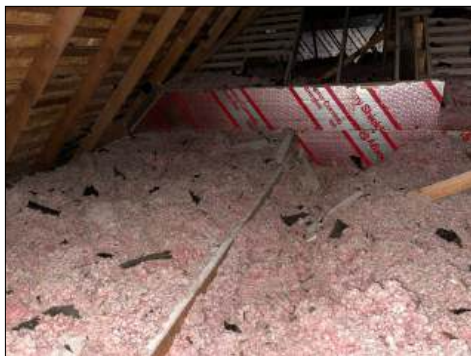
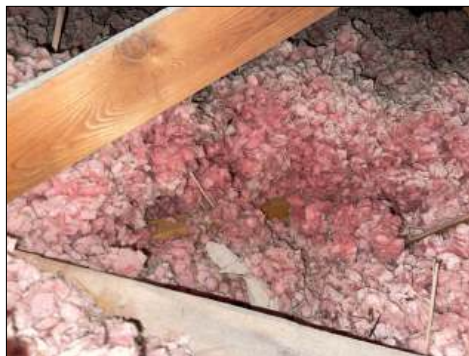
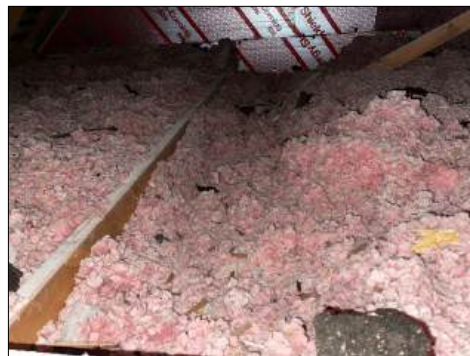
7.3. There has been foot traffic in areas in the attic which has lowered the height of the insulation that should be corrected.

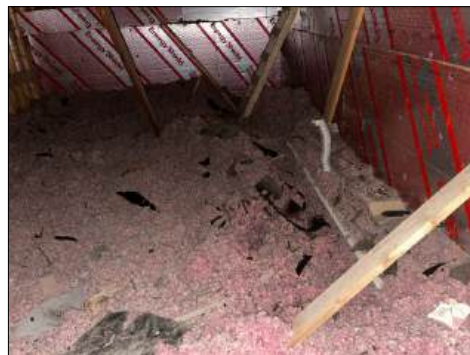
Exposed Ceiling Joists noted in several areas or throughout. This can cause Thermal Bridging which is when heat escapes into the cold attic space causing condensation issues. Recommend additional insulation to correct this. There needs to be insulation added now!

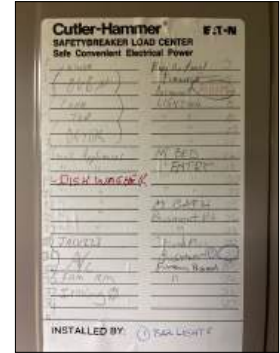
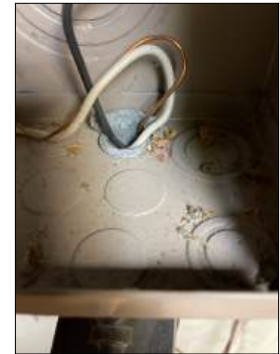
1.5. There is a receptacle attached to the bottom of the main electric panel in the exterior ceiling of the electric cable is missing and half of the cable connector clamp is missing.

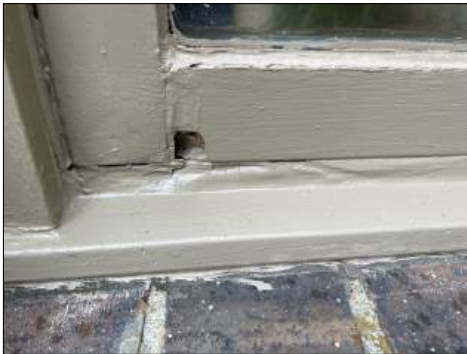
1.13. all Windows are missing Screens

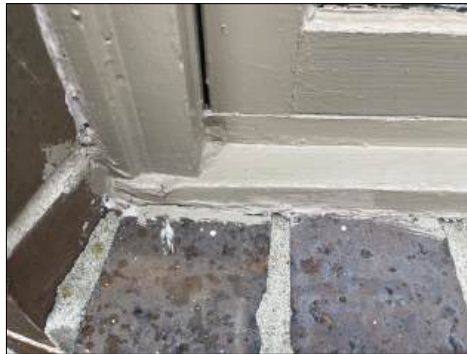
The kitchen breakfast nook bay window, north window bottom frame and window glass rails and sash are rotted out.

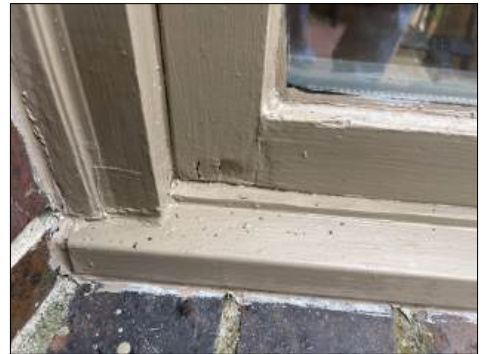
Kitchen breakfast nook bay window second window from the north side has water damage to the bottom of window casement and the window sill.

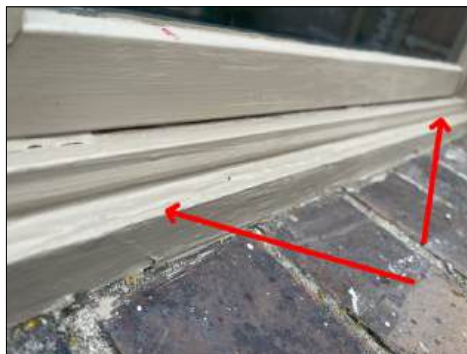
The kitchen breakfast nook bay windows, both of the south windows have rotted window extrusions and bottom window casement.

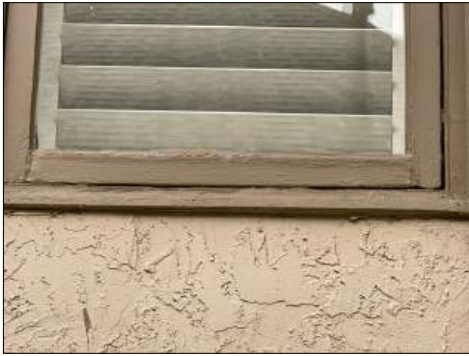
The casement window on the southside between the electric meter and the air conditioning condenser has water damage to the window glass extrusions in the bottom casement and sill area.

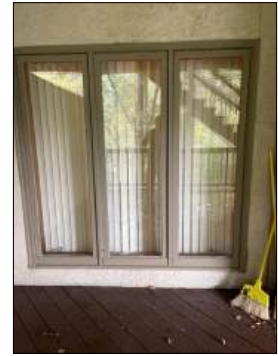
Southside lower window west of the air conditioning condenser is in very poor condition. Brick molding has been patched in with sections, the window sags and there is a gap at the bottom.

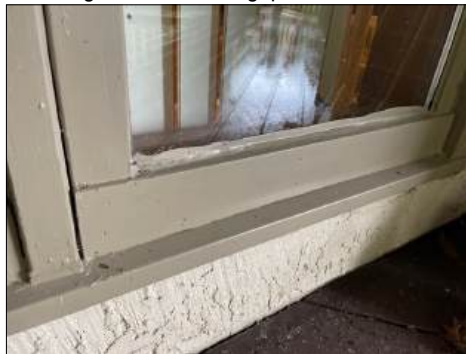
The triple casement windows on the lower deck north side of the brick chimney are in poor condition and has had woods/trim attached to the bottom of the windows.

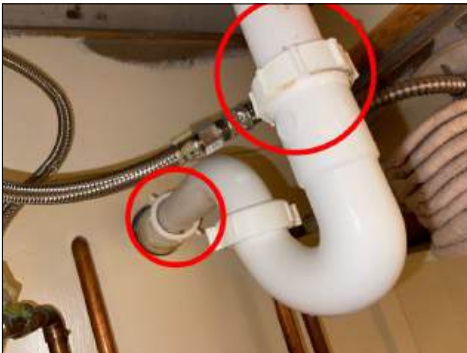
2.1. Evidence of a leak at the east sink drain line trap connection and wall drain connection as well as the hot water shut off valve.

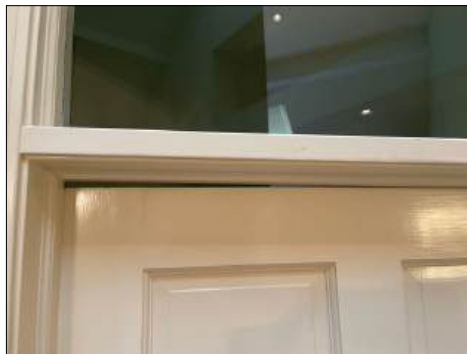
3.1. Recommend adjusting the doors hinges so it creates a seal around the casement instead of having a gap along the top

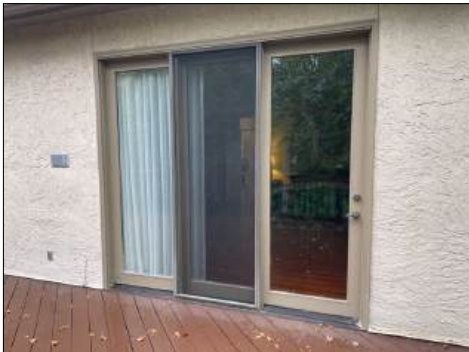
12.5. There is Water Damage at the Door Casement south side.

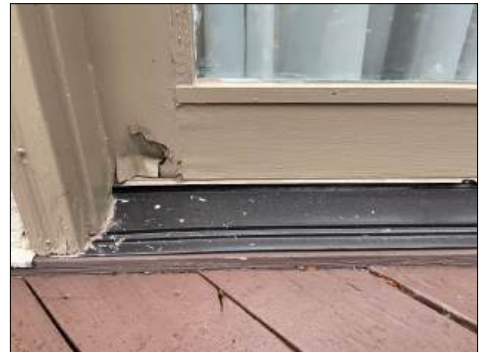
Water damage to the exterior vertical wood section between the opening door in the center stationary section.

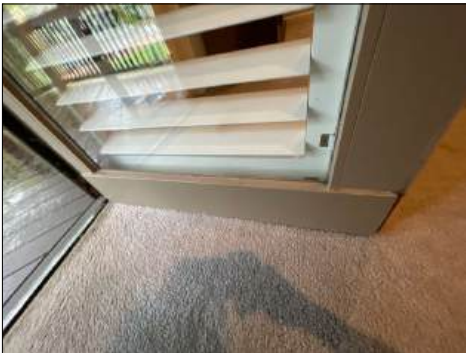
11.3. Recommend caulking the corners of the casement behind the weatherstrips at the threshold. There's gaps can allow bugs and possibly water into the home.

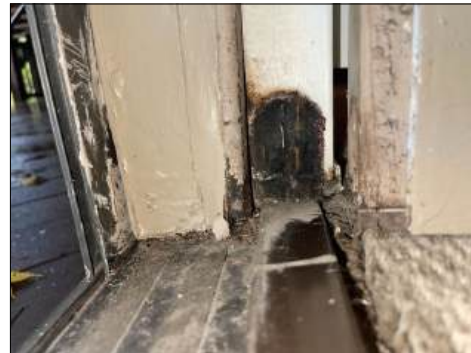
Seems as though a piece of wood trim was placed along the bottom of the exterior of the side. This could be evidence of previous wood damage on the door

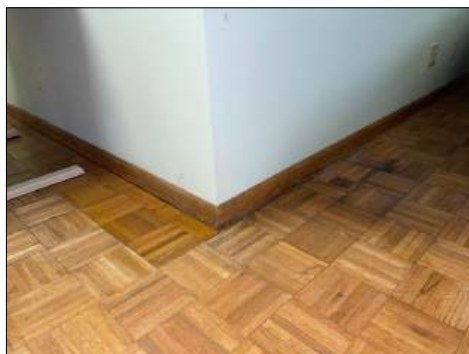
7.1. Evidence of water damage around the corner of the north wall and north end east wall. Several delaminated hardwood squares and some replaced wood squares noted.

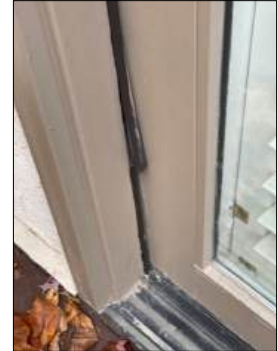
Damaged weatherstripping

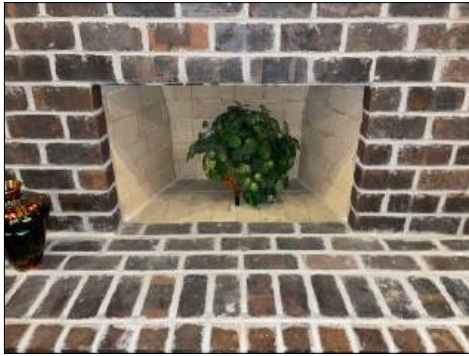
Hearth crack along the north end
