Property Inspection Report

Property Address: Undisclosed

Report Prepared for: Example EIFS Report

Inspection Date: 10/26/2021

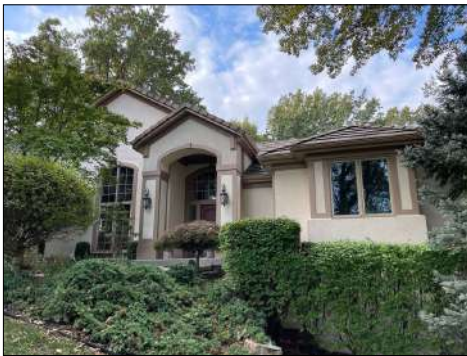
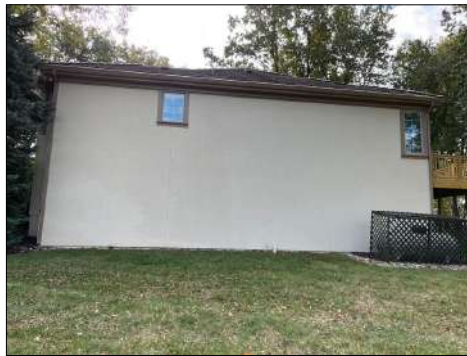
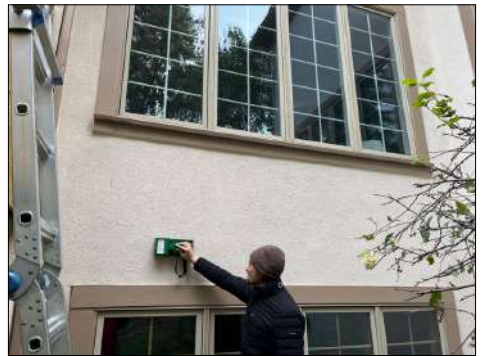
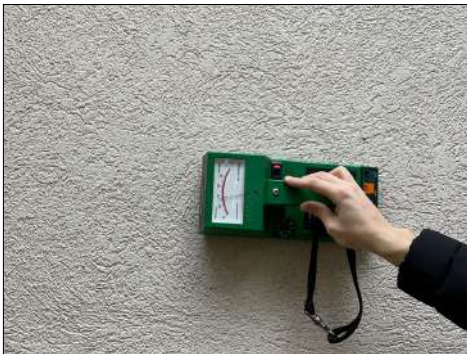
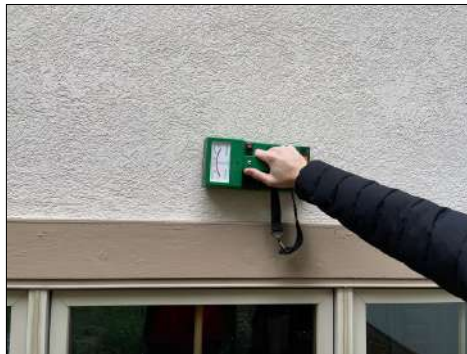
1.7. The EIFS at the front porch north side just above the concrete surface is cracked and should be sealed.

The EIFS at the front porch northside just above the concrete surface is cracked and should be sealed.

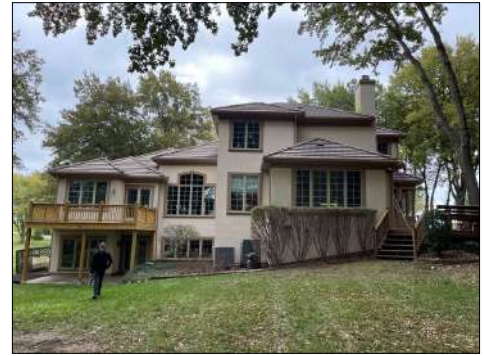
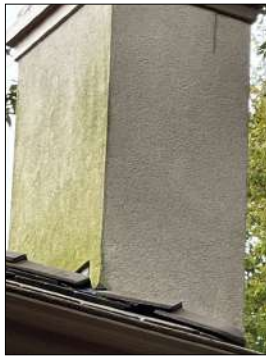
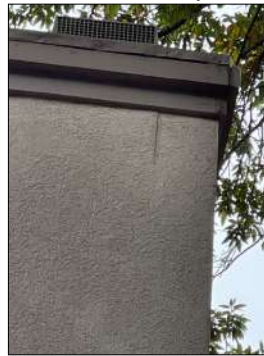
1.8. On the exterior west side of the living room above the north side windows, there is a gutter and there is excessive moisture content at the gutter area and below the soffit proximately 12 feet (basement foundation sill plate).

1.9. The EIFS BASE COAT mesh is visible at the end of the gutter above the living room exterior above the North side of the window. This may be where the moisture is getting in behind the surfaces. There was high moisture content all the way down to the basement. There's also evidence of water intrusion and Mold Growth on the interior basement surfaces on the exterior wall sheathing and wall cavity.

On the exterior west side of the living room above the north side windows, there is a gutter and there is excessive moisture content at the gutter area and below the soffit approximately 12 feet (basement foundation sill plate). The EIFS BASE COAT mesh is visible at the end of the gutter above the living room exterior above the North side of the window. This may be where the moisture is getting in behind the surfaces. There was high moisture content all the way down to the basement. There's also evidence of water intrusion and Mold Growth on the interior basement surfaces on the exterior wall sheathing and wall cavity.

1.10. Once the exterior EIFS is removed at the North side of the Living room windows down towards the basement exterior pedestrian door, then the Plywood Wall Sheathing can be evaluated to see if it needs to be replaced or not.

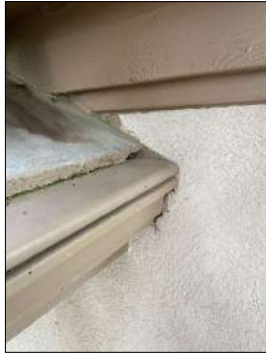
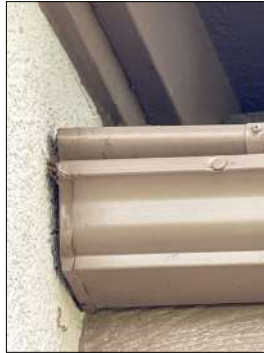
Missing Kick Out Flashing's need to be installed at: Both sides of the garage east bay window area
There's a kick out flashing on the west side above the north corner of the living room windows that was not properly installed. Since the stucco needs to be cut out there should be a proper kick out flashing installed.

Missing Kick Out Flashing's need to be installed at: Both sides of the garage east bay window area

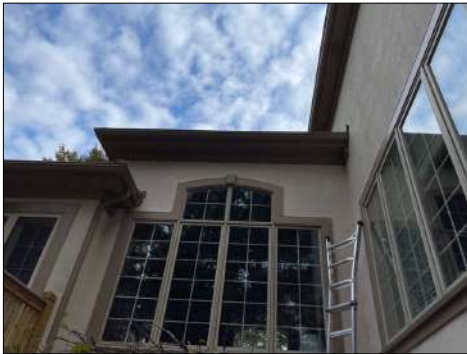
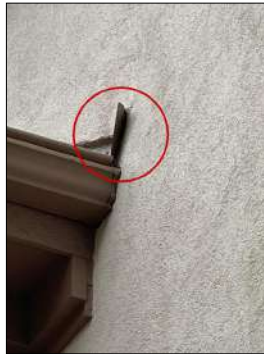
1.12. West side above the air conditioning condensers at the lower gutter running west to east, at the east end of the guttering the EIFS BASE coat Mesh is visible and the kick out flashing was not properly installed.

West side above the living room south side windows at the gutter running north to south, the kick out flashing was not installed properly and there is visible EIFS Base Coat Mesh at the end of the guttering.

2.6. Improperly installed kick out flashing on the west side above the air conditioning condensers that needs to be replaced since the stucco needs repairs anyway.
