# RC Certified Inspections

## Property Inspection Report

**Property Address: 119th St.**

**Report Prepared for: Example Commercial Bldg Inspection**

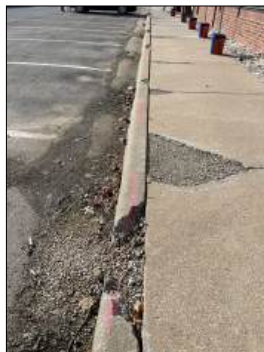
1.6. The front concrete curb along the sidewalk is broken up and deteriorated the entire length and needs to be replaced.

The front concrete curb along the sidewalk is broken up and deteriorated the entire length and needs to be replaced.

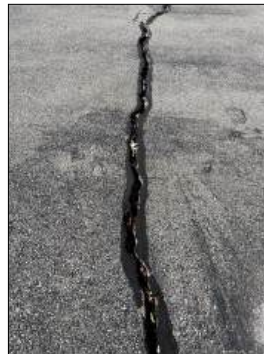
1.8. Rear parking Drive area west side towards the south west corner has a large opening in the asphalt that needs to be filled in to help prolong life and prevent tripping hazards.

Rear parking Drive area west side towards the south west corner has a large opening in the asphalt that needs to be filled in to help prolong life and prevent tripping hazards.

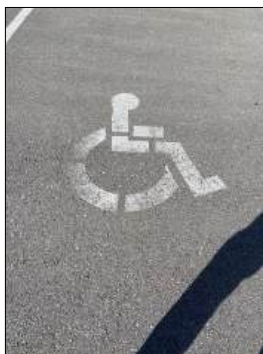
2.2. It is recommended that the handicap parking lot striping to be re-striped. They are faded and should be corrected.

It is recommended that the handicap parking lot striping to be re-striped. They are faded and should be corrected.

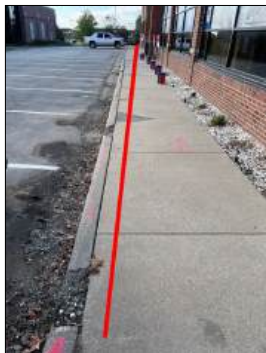
4.4. Tripping hazard(s) noted: East side front of the building

Tripping hazard(s) noted:

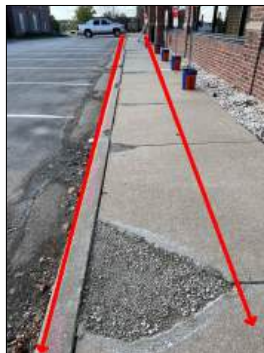
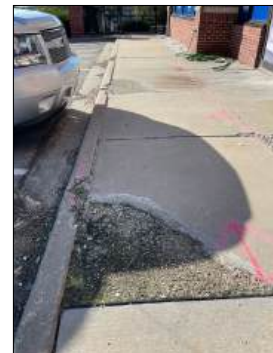
4.5. Sidewalk has a lot of deterioration along the front building area.

Sidewalk deterioration along the front sidewalk area.

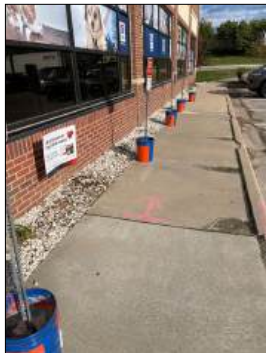
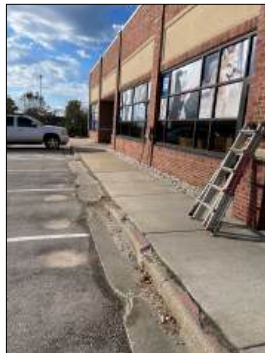
5.4. Along the front east side of the building between the brick foundation and sidewalk area is soil with no evidence of drainage. This is keeping water trapped between the sidewalk and the brick surfaces.

Along the front east side of the building between the brick foundation and sidewalk area is soil with no evidence of drainage. This is keeping water trapped between the sidewalk and the brick surfaces.

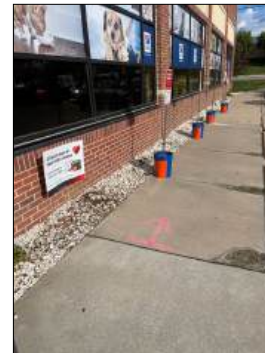
5.5. Soil and ground covering must be below the bottom brick surfaces so that water does not become trapped in the brick wall. This is an issue all along the building.

Soil and ground covering must be below the bottom brick surfaces so that water does not become trapped in the brick wall. This is an issue all along the building.

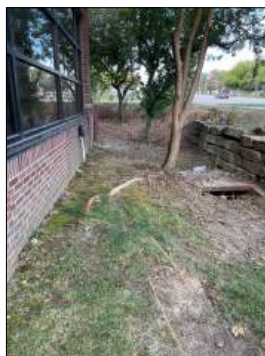
6.2. Trees are within 6 feet of foundation. Monitor for potential root damage. Recommend removal. Referral: Bill Edington, D&B Tree Service at (913) 206-1533.

Trees are within 6 feet of foundation. Monitor for potential root damage. Recommend removal. Referral: Bill Edington, D&B Tree Service at (913) 206-1533.

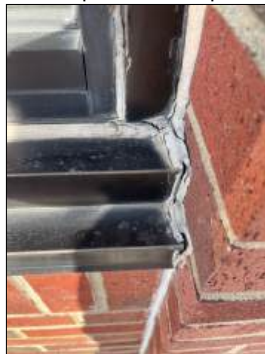
1.4. Exterior store front windows and bottom sill trim areas have sealant that is missing or opened. Need to clean up these areas and reseal.

Exterior store front windows and bottom sill trim areas have sealant that is missing or opened. Need to clean up these areas and reseal.

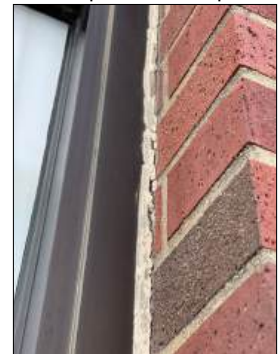
Caulk where Trim meets Siding, Stucco, Brick, Etc.

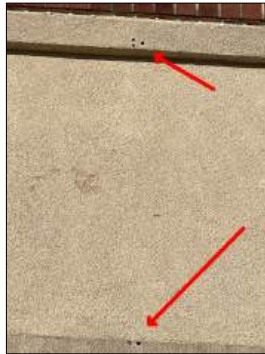
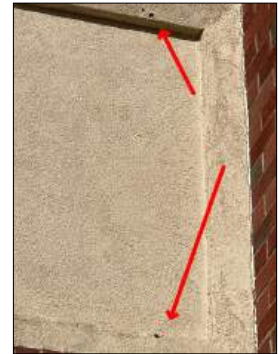
1.5. There are areas of the front drivit stucco material That has holes to the surfaces that needs to be repaired. Check all incorrect as needed.

There are areas of the front drivit stucco material That has holes to the surfaces that needs to be repaired. Check all incorrect as needed.

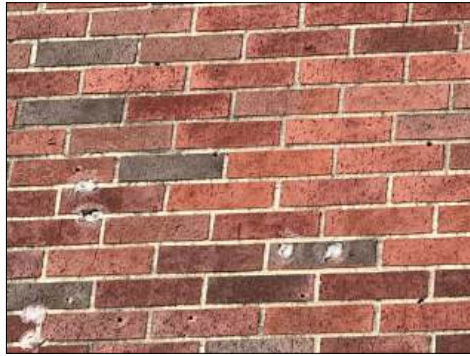
There are areas on the front of building at the upper brick where it looks like there has been signs installed and there are holes in the surface of the brick and mortar that should be sealed or tuck pointed.

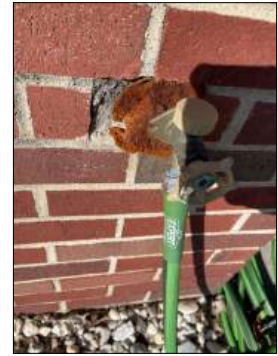
Need to properly seal up with And exterior sealant at the east side hose bib.

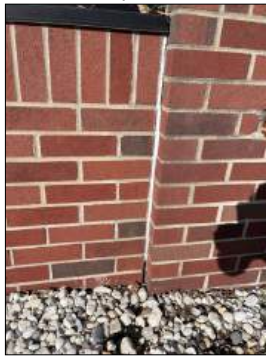
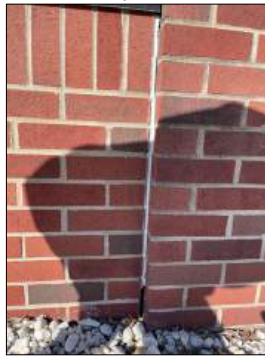
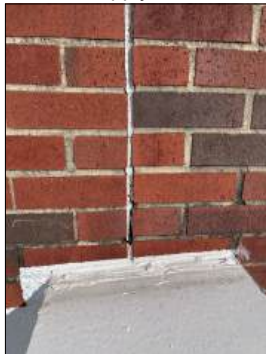
1.8. There are a few vertical brick joints that the sealant is deteriorated. Need to clean out these areas and apply new sealant.

There are a few vertical brick joints that the sealant is deteriorated. Need to clean out these areas and apply new sealant.

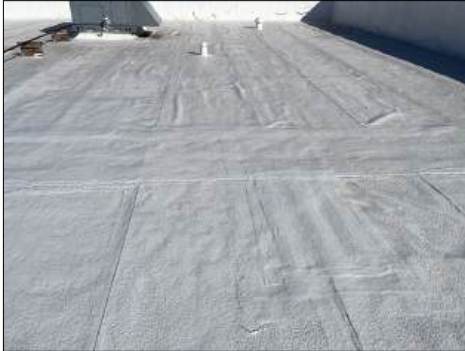
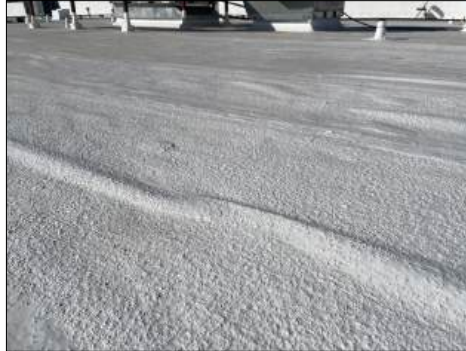
There are a lot of bubbles and wrinkles in this old rolled asphalt material. There are also several areas that it been patched.

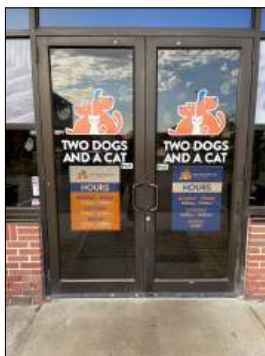
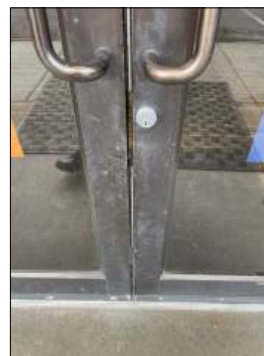
1.1. Need to install new door casement weatherstrips due to damage and/or current ones don't seat at the threshold and/or not properly fitted at the upper corners. Large gaps noted between the two doors.

Need to install new door casement weatherstrips due to damage and/or current ones don't seat at the threshold and/or not properly fitted at the upper corners. Large gaps noted between the two doors.

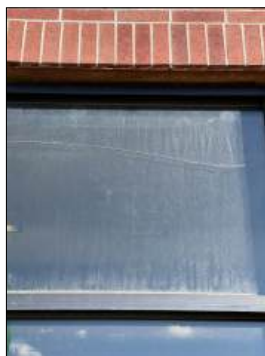
Window Pane Glass is Cracked/Broken at: Center exterior doors above it to the east top window.

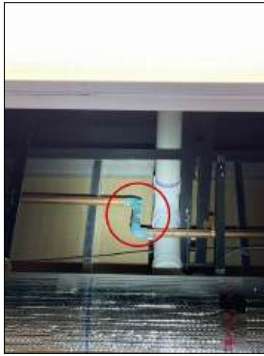
Evidence of leaking pipe in south boarding room east wall above the 3rd dog pin

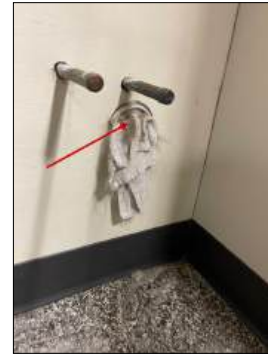
Grooming room east wall north end has a drain pipe that was not capped off properly.

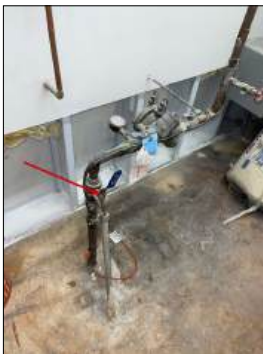
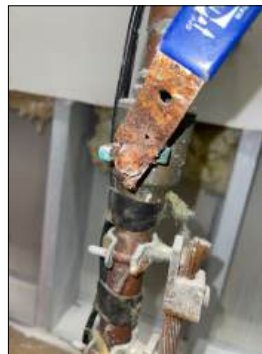
Shut off valve is very rusted. Recommend replacing

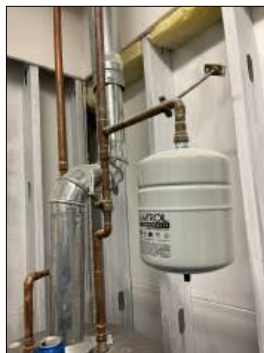
6.2. Tank currently has no support and needs some asap to prevent damage to the water line

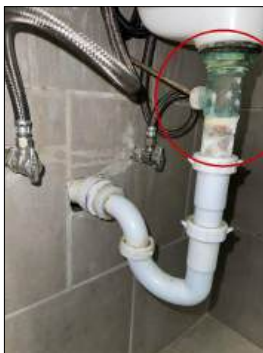
Sink copper drain tailpiece has evidence of corrosion and needs to be replaced.

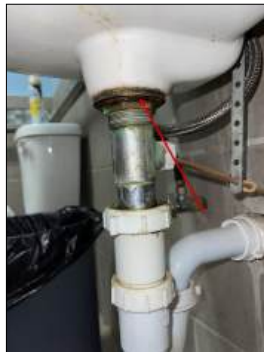
Evidence of a leak at the sink flange

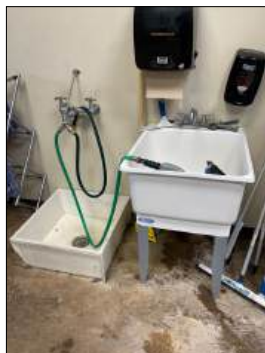
2.1. The sink basin is leaking at the trap connection

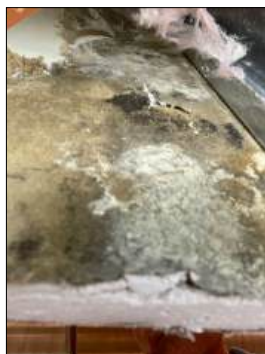
Orange room west wall mold growth above wall cut out at the higher wall cut out areas.

1.3. Mold remediation and clean-up is required based on the visible issues observed and were noted above. It is crucial for the mold remediation activities to be performed in organized phases to ensure reduction of mold spore levels and to prevent cross contamination of other areas. If not handled properly, the initial problem could develop into a larger, costlier project.

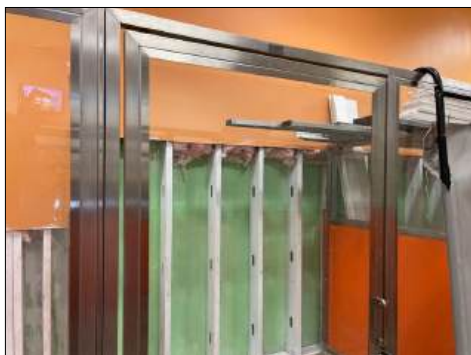
Orange room west wall mold growth above wall cut out at the higher wall cut out areas.

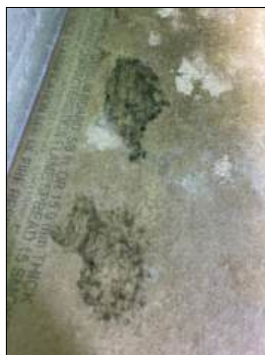
Orange room west wall mold growth above wall cut out at the higher wall cut out areas.

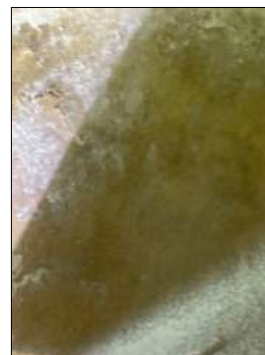
Orange room west wall mold growth above wall cut out at the higher wall cut out areas.

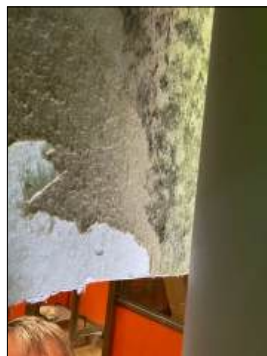
Orange room west wall mold growth above wall cut out at the higher wall cut out areas.

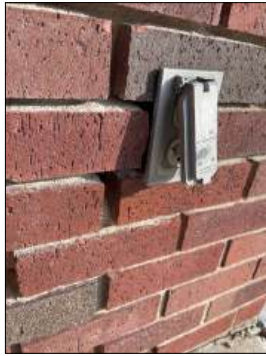
The Exterior Receptacle Cover is Damaged at: Front entrance,

- 1.1. Need a Licensed Electrician to Evaluate the Electrical Safety & Defect issues noted. Referrals: Teague Electric at 913-529-4600 or Tann Electric at 913-236-7337.

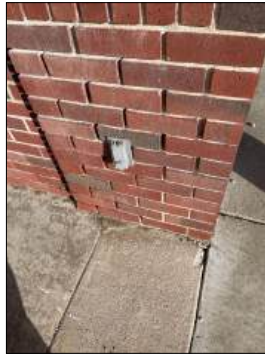
The receptacle at the front entry was dead at the time of the inspection. There may be a GFCI receptacle on the interior.

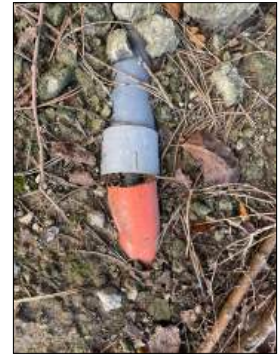
On the exterior Northside north west corner there is an electrical conduit next to the building surface and the conduit has separated leaving the cable exposed.

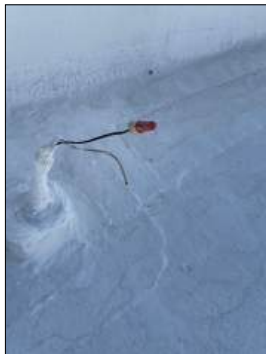
There is open electrical on the roof along the east side south of center. These are not properly capped off either in a junction box or they need to be disconnected from the electrical system.

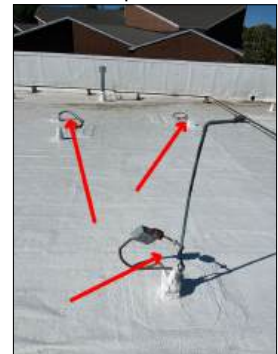
There is open electrical on the roof along the east side south of center. These are not properly capped off either in a junction box or they need to be disconnected from the electrical system.

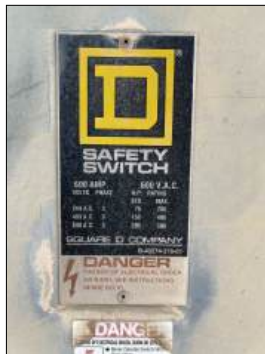
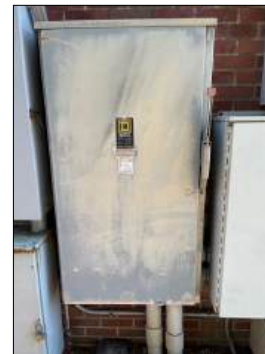
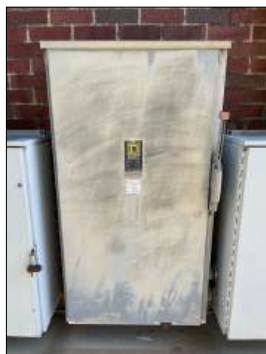
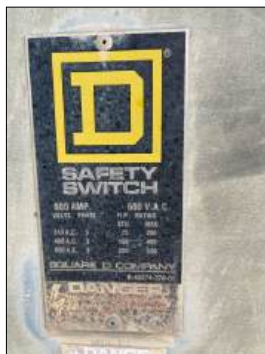
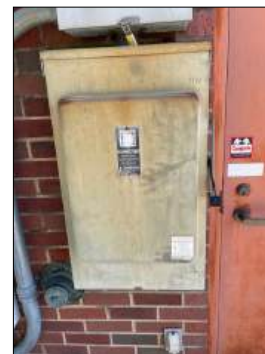
3.1. Four electric meters on the west side NW corner: 4- Electric Meters, Only 3- Exterior Main Disconnects noted and the South 200amp Disconnect is OFF.

4- Electric Meters, Only 3- Exterior Main Disconnects noted and the South 200amp Disconnect is OFF.

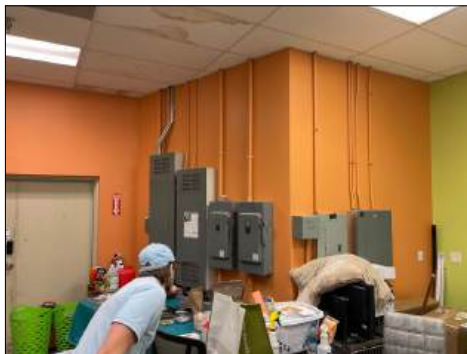
1-125 amp disconnect, 2-200 amp disconnects and the top 200 amp is a spare.

2-125 amp disconnect

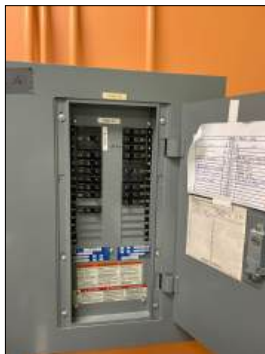
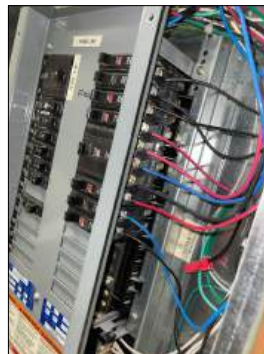
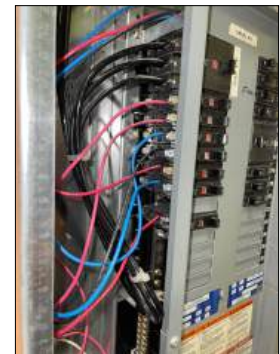
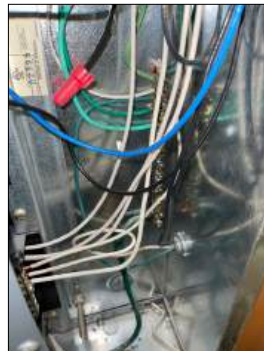
Starting with the 2008 National Electric Code, the only acceptable way to wire a sub panel is with a four-wire feed. Two hots, one ground, and one neutral wire. The grounds and neutrals must be isolated.

When the Grounds and Neutrals are not separated, we have to recommend a Licensed Electrician to Evaluate the System.

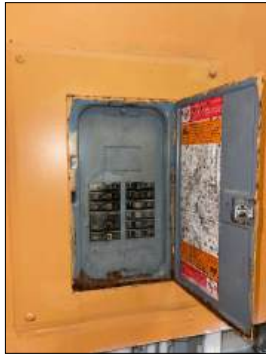
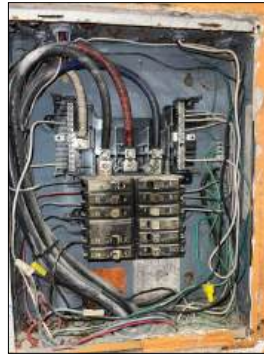
Missing Knockout(s) Plugs need to be installed to keep mice out of panel box and to avoid potential electrocution hazard and to contain any possible sparks or fire from exiting into the wall cavities:  
top of panel

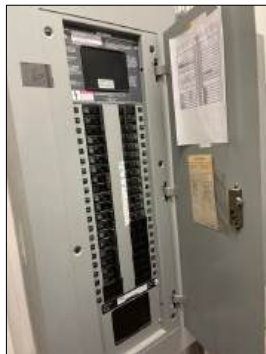
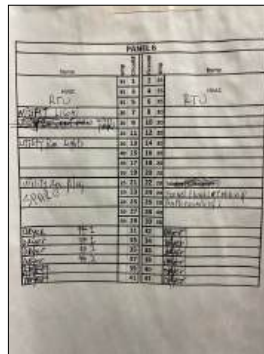
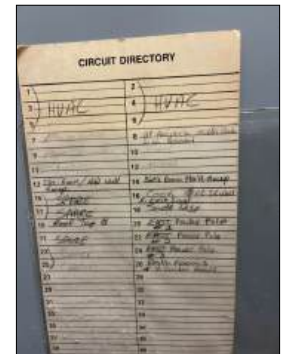
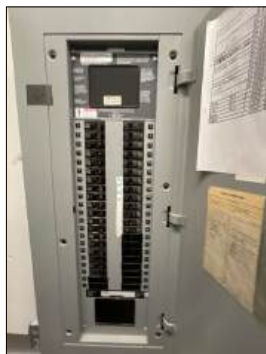
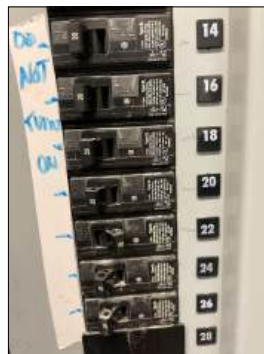
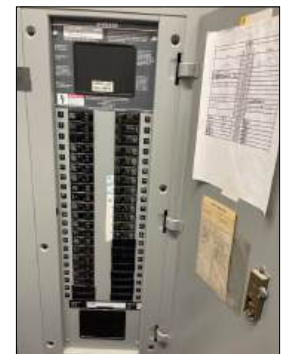
The electric panel on the right side has 7- 20 amp breakers and there is a note do not turn on. All the breakers except for number 22 are turned on. Just needs to be evaluated and updated.

1.2. Need a Licensed Electrician to Evaluate the Electrical Safety & Defect issues noted. Referrals: Teague Electric at 913-529-4600 or Tann Electric at 913-236-7337.

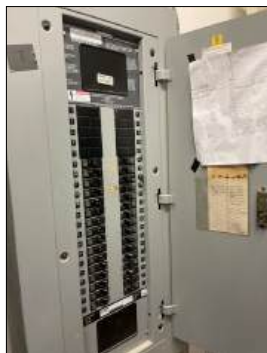
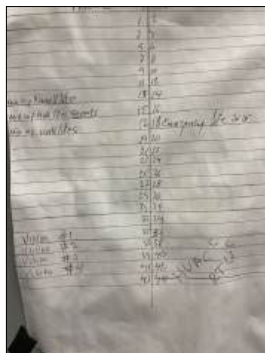
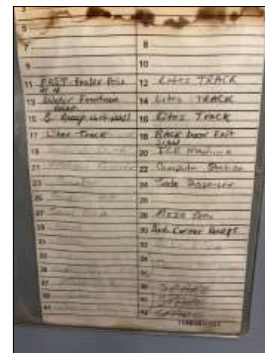
1.2. There are 12 breakers there in the off position. Recommend an answer to why and or have an evaluation performed by license electrician.

1.1. Need a Licensed Electrician to Evaluate the Electrical Safety & Defect issues noted. Referrals: Teague Electric at 913-529-4600 or Tann Electric at 913-236-7337.

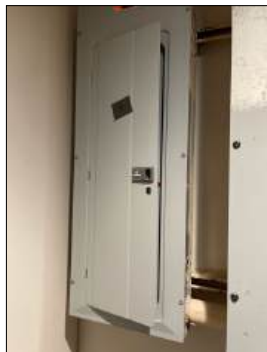
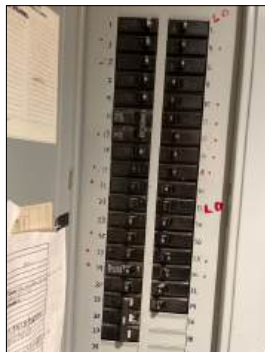
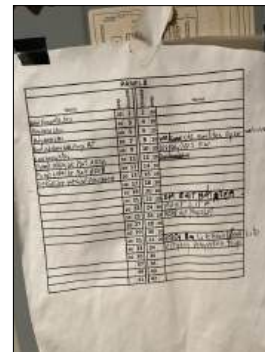
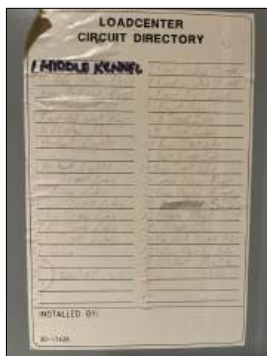
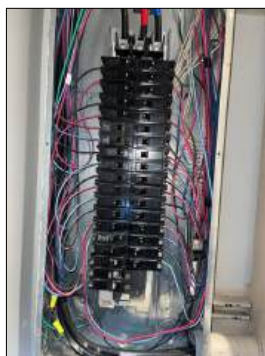
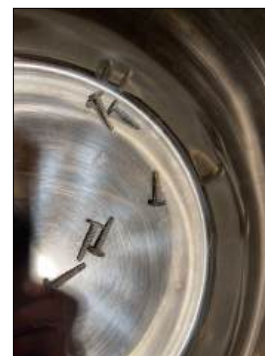
Sharp-pointed metal screws are holding the panel cover in place. These are a potential hazard as they may puncture wire insulation and electrify panel box, becoming a shock or electrocution hazard. These screws need to be replaced with approved, flat-tipped screws.

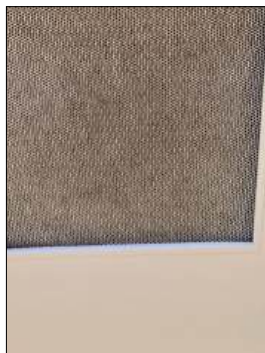
The return air vents are very dirty

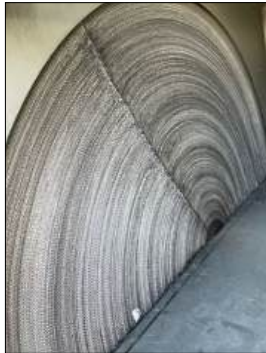
The circular rotating fins are badly damaged because of air filters being loose and laying up against the surfaces on both sides. Complete evaluation required.

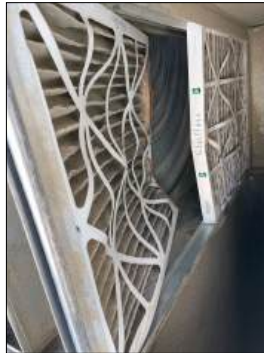
The circular rotating fins are badly damaged because of air filters being loose and laying up against the surfaces on both sides. Complete evaluation required.

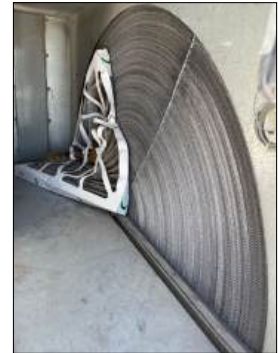
The circular rotating fins are badly damaged because of air filters being loose and laying up against the surfaces on both sides. Complete evaluation required.

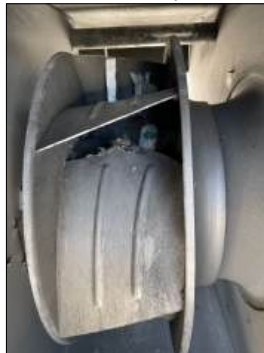
There is debris in the rotating fan blades.

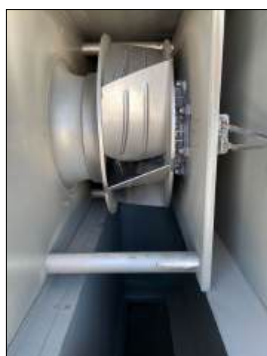
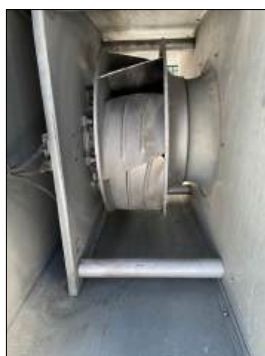
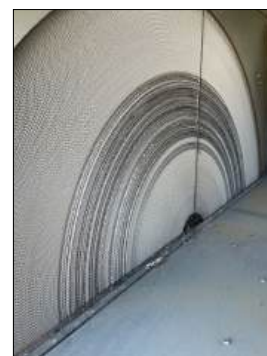
Rotating wheel with fins has some damage on the west side. Doesn't appear to be an issue at this time but could restrict some airflow.

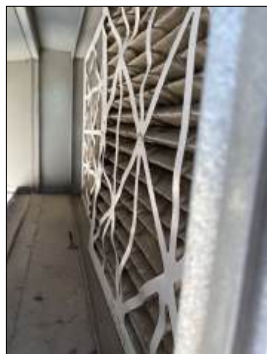
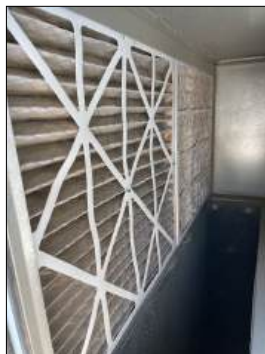
3.2. One of the prefilters are missing.

One of the prefilters are missing.

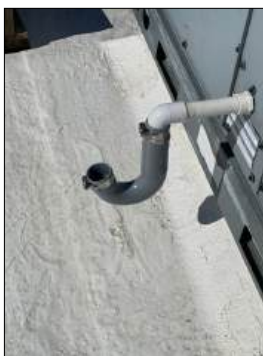
The air conditioning condensation drain needs to be extended to the west roof drain.

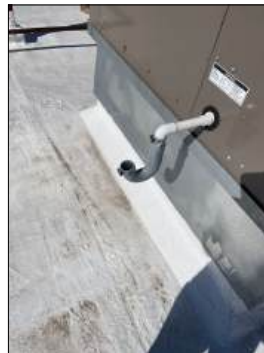
**2.1. Air conditioning condensation drain line needs to be extended to the roof Westside drain.**

Air conditioning condensation drain line needs to be extended to the roof Westside drain.

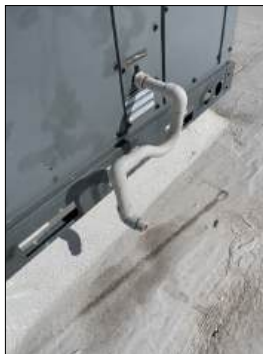
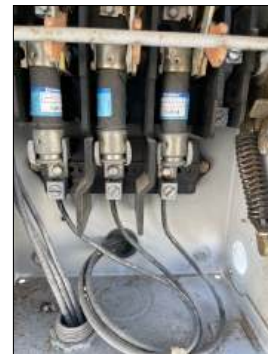
- 2.1. Heating system was working as intended at the inspection.
- 2.2. Manufacturers maximum fuse is 45 A and there are 40 amp fuses present.
- 2.3. Air conditioning condensation drain needs to be extended to the west side roof drain.

Air conditioning condensation drain needs to be extended to the west side roof drain.

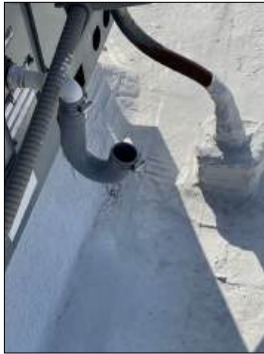
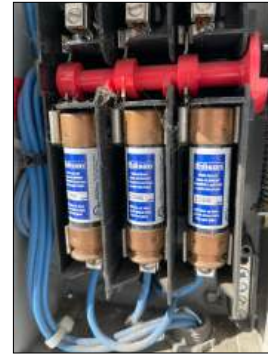
**2.1. Air conditioning condensation drain line needs to be extended to the west roof drain.**

Air conditioning condensation drain line needs to be extended to the west roof drain.

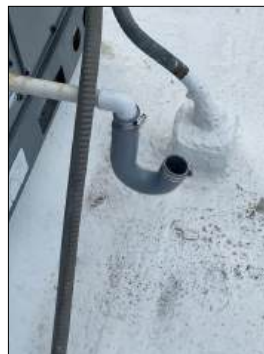
**2.1. The air conditioning condenser drain line needs to be extended to the west side roof drain.**

The air conditioning condenser drain line needs to be extended to the west side roof drain.

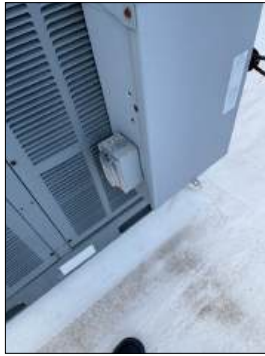
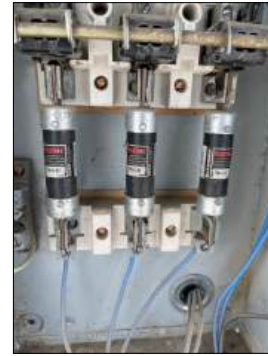
9.3. Manufactures listed maximum fuse is 45 A but the main disconnect has 90 amp fuses.

There is an exterior receptacle on the exterior of the unit disconnect box but Manufactures listed maximum fuse is 45 A but the main disconnect has 90 amp fuses. Circuit is 30 Amps

9.2. Need a Licensed Electrician to Evaluate the Electrical Safety & Defect issues noted. Referrals: Teague Electric at 913-529-4600 or Tann Electric at 913-236-7337.

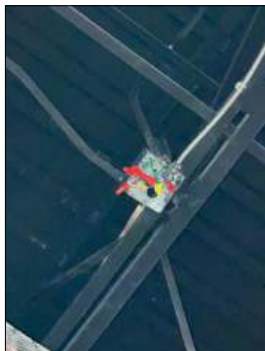
#### 2.2. Junction Boxes missing either Cable Connectors, Cover or Knock-Out Plugs at: east side above 3rd room from south, above west side sw corner room

Junction Boxes missing either Cable Connectors, Cover or Knock-Out Plugs at: east side above 3rd room from south

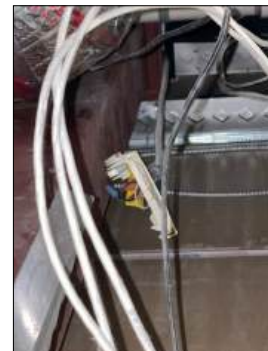
Junction Boxes missing either Cable Connectors, Cover or Knock-Out Plugs at: above west side sw corner room

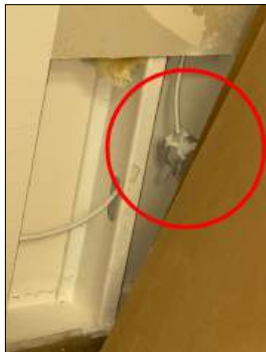
Hanging junction box: West boarding 2nd room from south NW corner

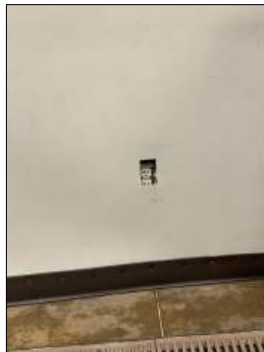
2.3. Missing or Damaged Receptacle Covers at: west boarding east wall 2nd dog pin from north

Missing or Damaged Receptacle Covers at: west boarding east wall 2nd dog pin from north

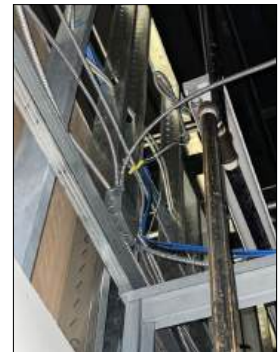
2.4. There are spliced electrical circuit wiring that must be in proper junction boxes with cable connectors and cover at: ceiling above south boarding 3rd room from west boarding room

There are spliced electrical circuit wiring that must be in proper junction boxes with cable connectors and cover at: ceiling above south boarding 3rd room from west boarding room

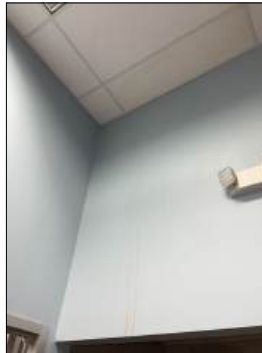
3.1. There is evidence of moisture intrusion noted. We are recommending water intrusion investigation. Water intrusion could develop mold growth on the surfaces. RC Certified Inspections can provide this investigation. Located at: west boarding west wall south end, could be due to older roof; South boarding along west white wall at floor

There is evidence of moisture intrusion noted. We are recommending water intrusion investigation. Water intrusion could develop mold growth on the surfaces. RC Certified Inspections can provide this investigation. Located at: west boarding west wall south end, could be due to older roof

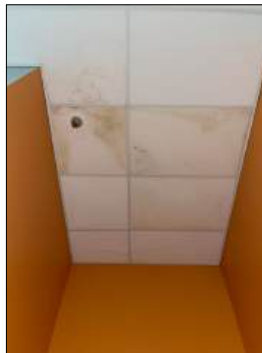
4.1. Evidence of Water Stains noted at: west boarding room above exterior door

4.3. Evidence of Mold-Like substance and further evaluation is recommended. Located at: west boarding above exterior door

4.2. Recommend RC Certified Inspections to perform a Moisture/Water Intrusion Investigation and Mold Inspection.

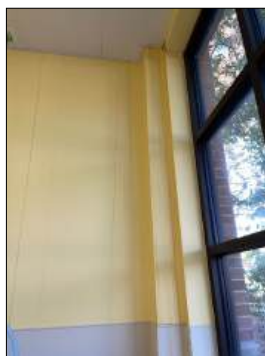
There's brown water staining going down the wall in the north west corner of the Surgery room

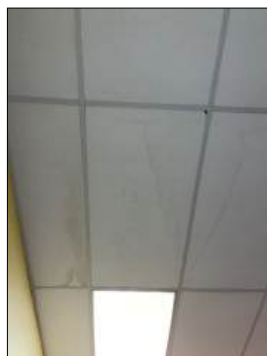
- 2.1. Evidence of Water Stains noted at: above the east door (could be caused by old roof)

Evidence of Water Stains noted at: above the east door (could be caused by old roof)

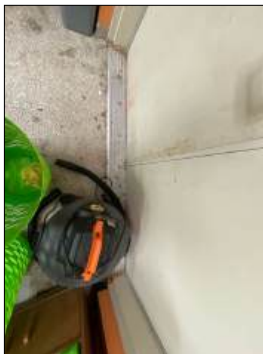
3.1. There is Water Damage at the Door Casement.

3.2. There is Water Damage at the Door surface.

3.3. The door without a sweep is allowing water into the building causing the casement and door itself to rust

There is Water Damage at the Door Casement and door itself

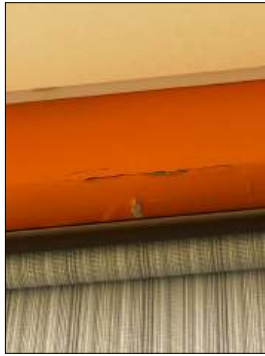
There is evidence of moisture intrusion noted. We are recommending water intrusion investigation. Water intrusion could develop mold growth on the surfaces. RC Certified Inspections can provide this investigation. Located at: East Exam room above windows

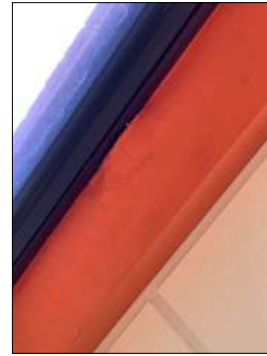
There is evidence of moisture intrusion noted. We are recommending water intrusion investigation. Water intrusion could develop mold growth on the surfaces. RC Certified Inspections can provide this investigation. Located at: north exam room above windows

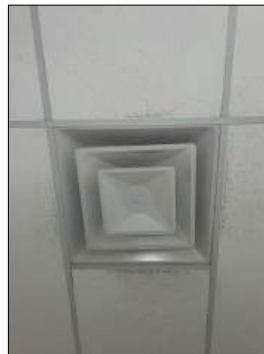
5.1. Evidence of Mold-Like substance and further evaluation is recommended. Located: Surrounding west hall supply vent

Evidence of Mold-Like substance and further evaluation is recommended. Located: Surrounding west hall supply vent

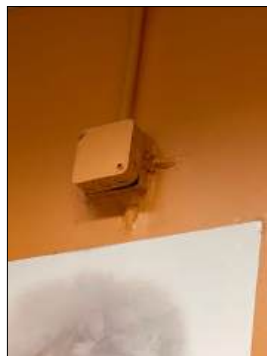
Junction box not sitting flush with second box at: north boarding sw corner west wall

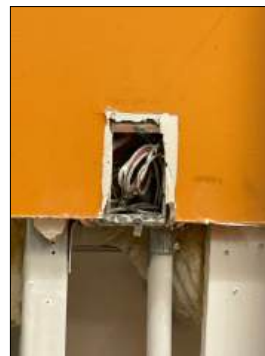
1.3. Junction Boxes missing either Cable Connectors, Cover or Knock-Out Plugs at: north boarding west wall south end

Junction Boxes missing either Cable Connectors, Cover or Knock-Out Plugs at: north boarding west wall south end

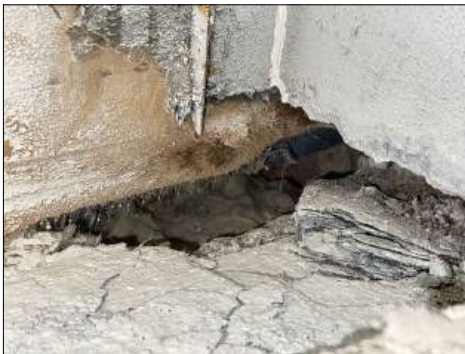
3.1. Void under the center west wall in the north boarding room and under electric panel

Void under the center west wall in the north boarding room

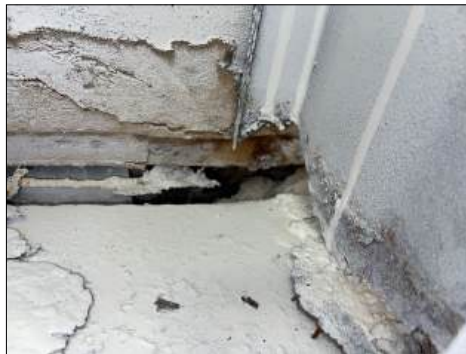
Void under the center west wall in the north boarding room

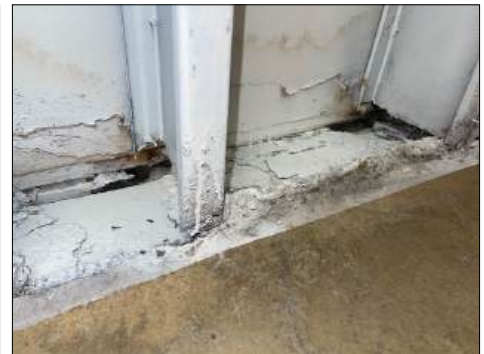
Void under the center west wall in the north boarding room

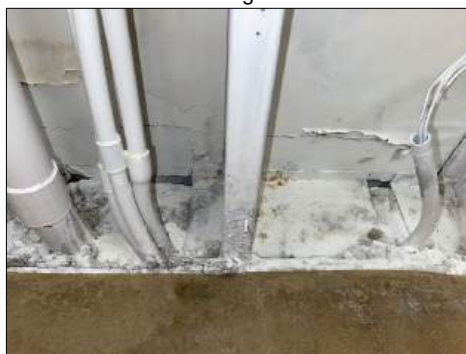
Void under the west wall in the north boarding room under electric panel

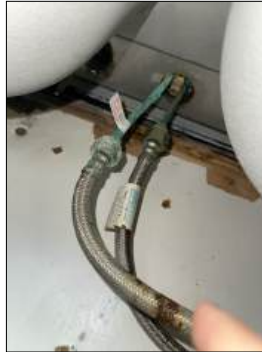
#### 2.1. Evidence of sink fixture leaking down into the lower cabinet

Evidence of sink fixture leaking down into the lower cabinet

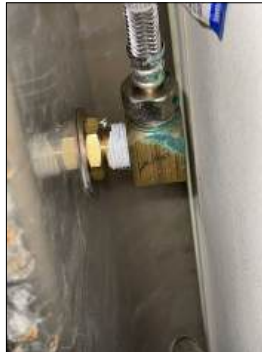
#### 3.1. Evidence of a leak at the coke water connection

Evidence of a leak at the coke water connection

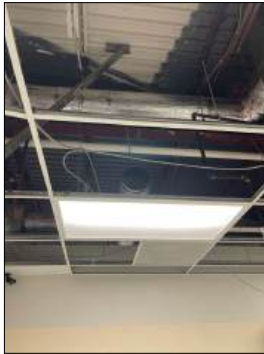
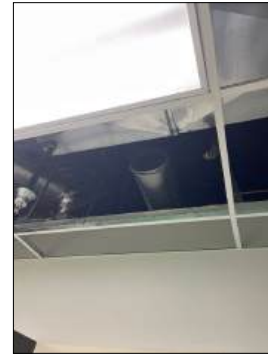
5.1. Missing return air vent at: 2 noted above ceiling

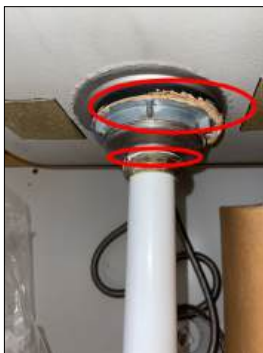
2.1. Evidence of a leak at the sink flange and the drain connection

Evidence of a leak at the sink flange and the drain connection

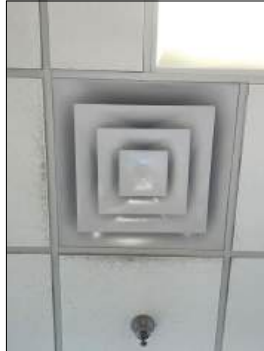
5.1. Evidence of Mold-Like substance and further evaluation is recommended.

Evidence of Mold-Like substance and further evaluation is recommended.

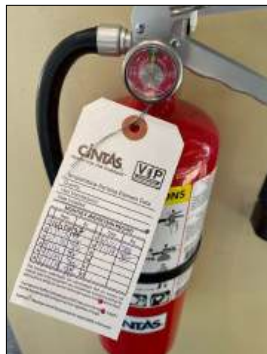
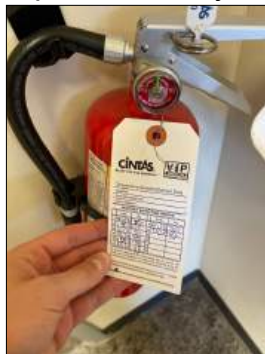
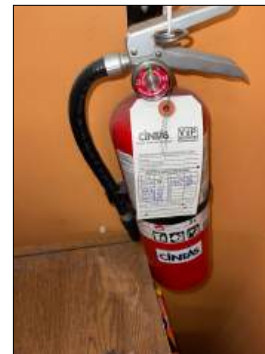
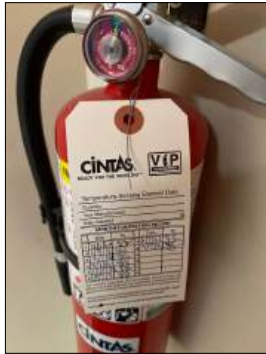
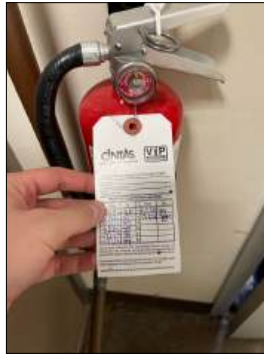
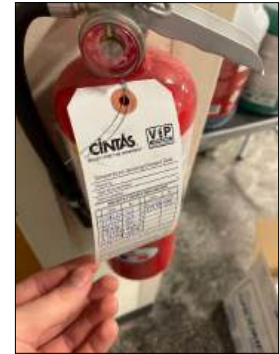
1.1. Quantity of Fire Extinguishers: 6

1.2. Date of Last Service. Needs to be Inspected Yearly! Date: 7/1/21

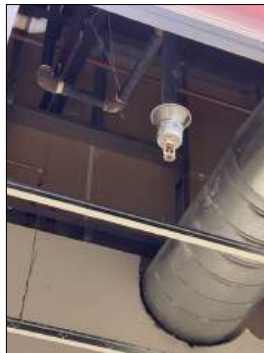
1.1. Our Inspectors DO NOT operate or test the Fire Sprinkler System Heads. We report Service and Inspection Dates and note any Visible Issues at the time of the Inspection:
