RC Certified Inspections

Property Inspection Report

Property Address: Cedar St.

Inspection Date: 10/27/2021

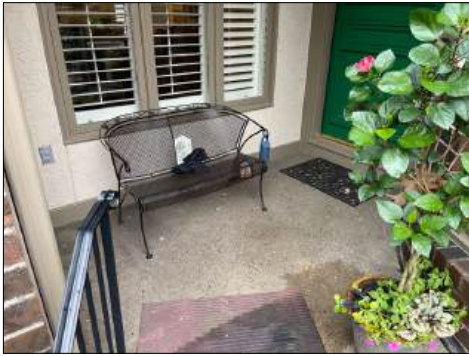
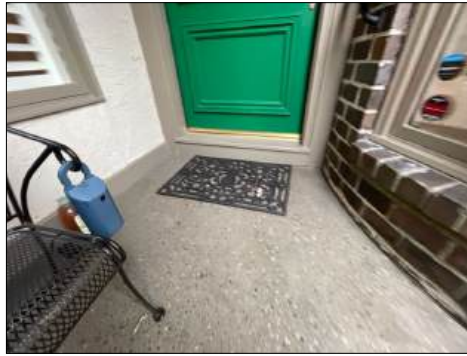
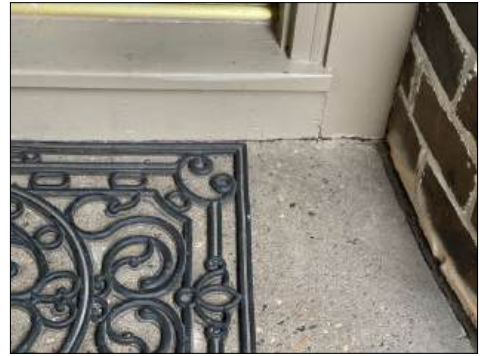
Where the concrete porch surfaces meets any siding or trim needs to be sealed with a Masonry Polyurethane caulk.

The wood trim under the front door threshold area is starting to get soft where it meets the concrete. Need to definitely get this caulked and sealed and monitor.

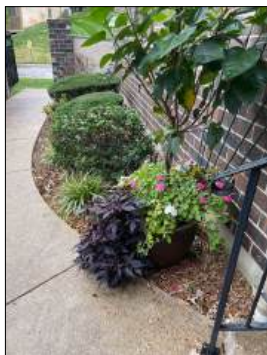
4.3. Soil slope and drainage within 5' of the foundation is Inadequate and needs to be corrected. The soil needs to be sloped and compacted at a 5 degree slope outward from the foundation. This is a 1" drop per foot out to 5', which is equal to a 5" drop at 5' out from the foundation. Keep the soil and ground covering at least 6" below any siding, trim, window openings or foundation vents (where applicable). Negative soil slope towards the foundation can cause foundation damage, basement slab heaving and cracking, water intrusion and mold. Negative soil slope with mulch holds more water against the foundation. This must be corrected and maintained! ** South side-All, North side of Garage

POOR DRAINAGE-CORRECT NOW

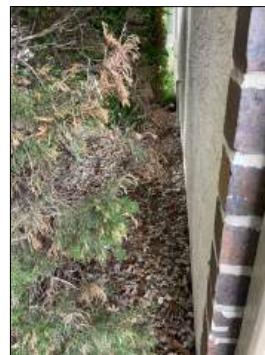
POOR DRAINAGE-CORRECT NOW, Southside all

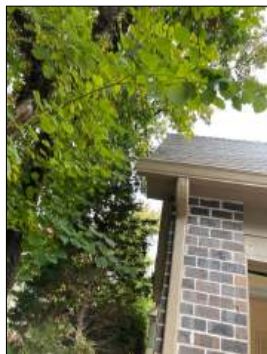
Tree limbs within 10 feet of roof should be trimmed away to provide air and sunlight to roof, while minimizing debris, damage & dampness to the roof surface. Referral: Bill Edington, D&B Tree Service at (913) 206-1533.

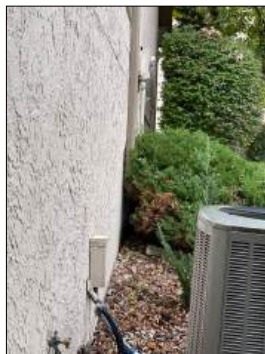
Prune or remove any plants that are in contact or within 12" of home to eliminate water damage to the siding surfaces or pathways for wood destroying insects.

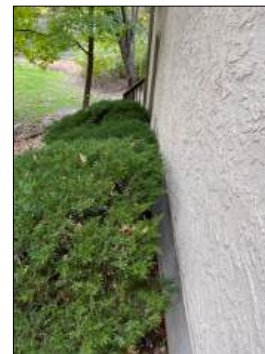
Prune or remove any plants that are in contact or within 12" of home to eliminate water damage to the siding surfaces or pathways for wood destroying insects.

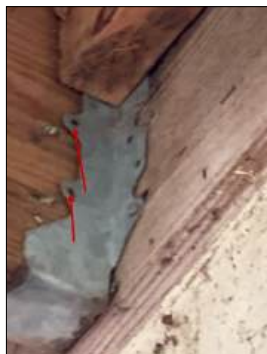
6.2. Joist hangers are missing fasteners were they attached to the sides of the floor Joists. JoistHangers must be installed using either Joist Hanger Nails or #8 or #10 Framing nails. Must have 8 fasteners per hanger. ** This needs to be done at the upper and the lower deck areas.

Joist hangers are missing fasteners were they attached to the sides of the floor Joists. JoistHangers must be installed using either Joist Hanger Nails or #8 or #10 Framing nails. Must have 8 fasteners per hanger.

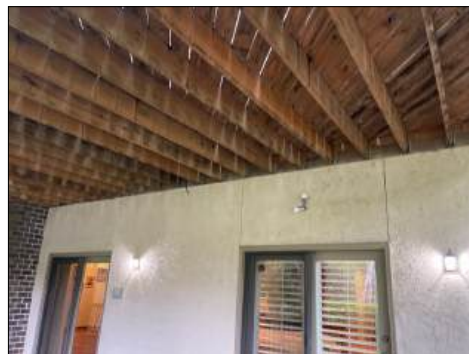
6.5. There are a few lag screws installed in the ledger board but there's not even close to being enough that is required.

Install Ledger-Loc Self Tapping screws with TWO screws between in pair of floor joists forming a W pattern across the length of the ledger board or pre-drill and install a 1/2" Lag Screw with flat washer between each pair of floor joists.

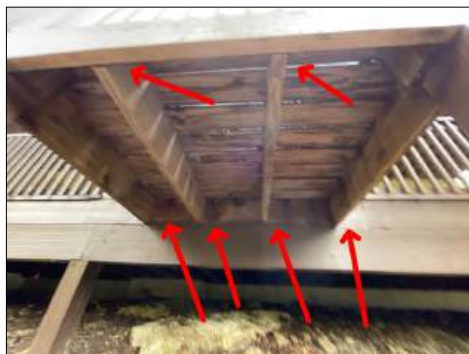
6.6. There needs to be 6 joist hangers installed Add the bottom of the stairs area of the lower deck.

There needs to be 6 joist hangers installed Add the bottom of the stairs area of the lower deck.

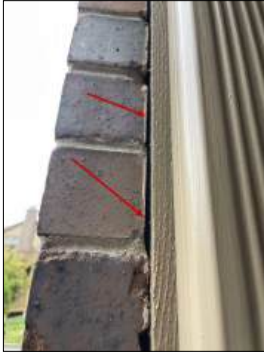
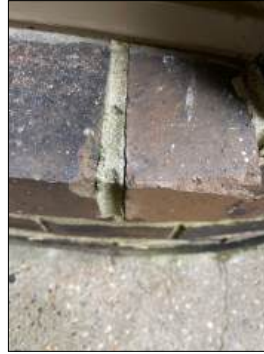
A brick on the north side of the garage at the front porch has a large gap between the brick and the corner trim. This needs to be properly filled in and sealed up. It appears that there are several other areas at the break edges and also needs to be sealed. Need to monitor the brick ledge mortar joints at the windows. They are just starting to open up and will need to be sealed in tuck pointed soon.

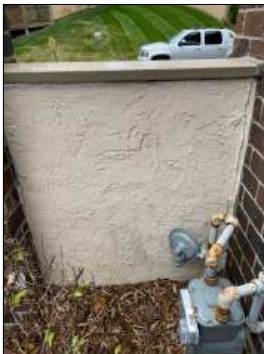
- 1.8. Both sides of the front entry stucco surfaces are loose. They are cracked and opening up at the edges and is in contact with the soil and ground covering.

Both sides of the front entry stucco surfaces are loose. They are cracked and opening up at the edges and is in contact with the soil and ground covering. Both sides of the front entry stucco surfaces are loose. They are cracked and opening up at the edges and is in contact with the soil and ground covering.

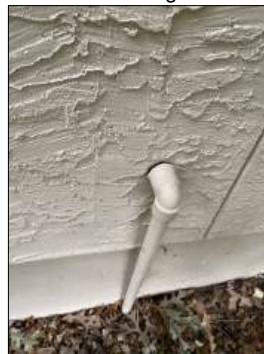
Need to seal up around the exterior sprinkler system electrical conduit on the south side of the garage.

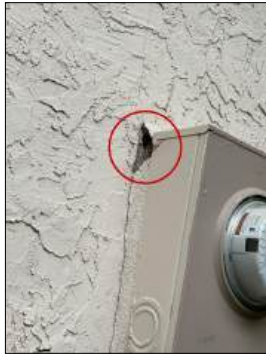
- 1.9. Water is getting in behind the main electric meter at the stucco surfaces causing water damage behind the stucco surfaces at the electric meter and the cable boxes. This area will need to be cut out and repaired.

Water is getting in behind the main electric meter at the stucco surfaces causing water damage behind the stucco surfaces at the electric meter and the cable boxes. This area will need to be cut out and repaired.

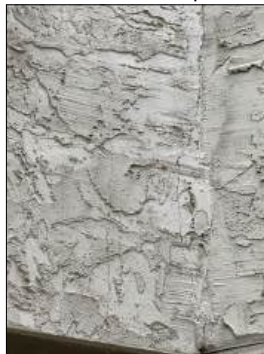
- 1.10. The south side of the Home Stucco surfaces has quite a few vertical cracks but also has a larger horizontal crack at the lower level west of the air conditioning condenser at a window. The smaller cracks can be skim coated Betty horizontal crack appears to have loose material and may need to be removed and replaced.

The south side of the Home Stucco surfaces has quite a few vertical cracks but also has a larger horizontal crack at the lower level west of the air conditioning condenser at a window. The smaller cracks can be skim coated Betty horizontal crack appears to have loose material and may need to be removed and replaced. ** Picture at MBR Bay Window

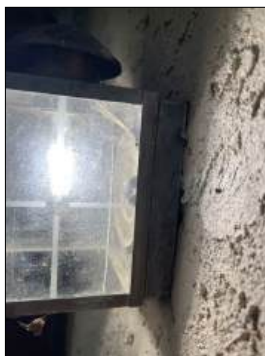
1.12. Caulk around the exterior light fixtures.

Caulk around the exterior light fixtures.

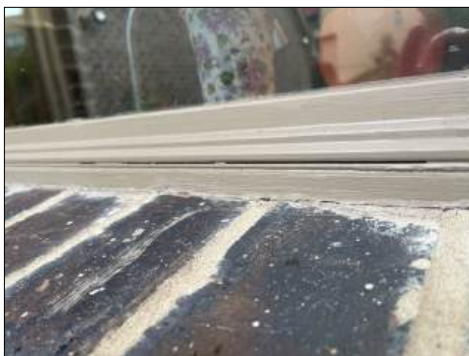
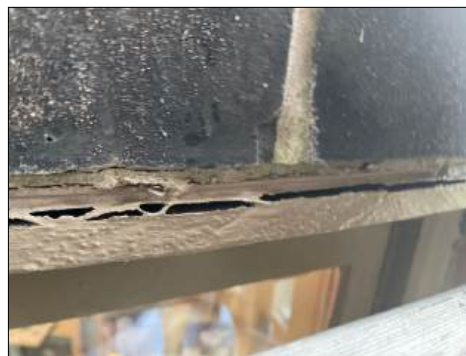
4.2. Need to caulk around the exterior of the windows and or window trim and or metal trim wrap. Basically touch up all the way around.

Need to caulk around the exterior of the windows and or window trim and or metal trim wrap. Basically touch up all the way around.

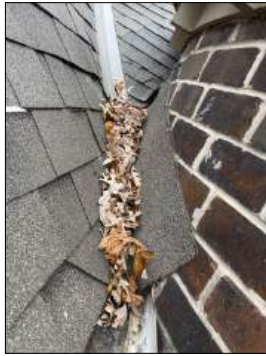
Above the front porch area north side where the valley comes down to the brick round structure, rolled asphalt material has been applied to the side the brick and it really should've been a TPO material. This is an area where there's been water intrusion down to the soffit area at the end of the gutter. ** Needs to be inspected every 5 years.

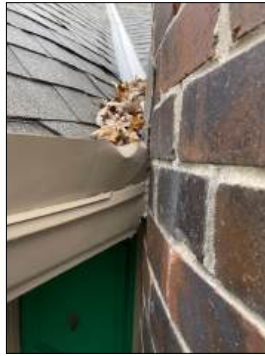
Above the front porch area north side where the valley comes down to the brick round structure, rolled asphalt material has been applied to the side the brick and it really should've been a TPO material. This is an area where there's been water intrusion down to the soffit area at the end of the gutter. ** Needs to be inspected every 5 years.

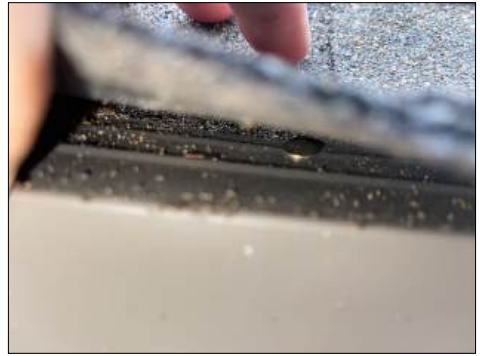
The eave Metal drip edges are installed on top of the felt paper/underlayment material instead of under the felt paper/underlayment material per manufacturers installation guidelines. This is also required by the majority of the City Codes.

Also, if Ice and Water Shield is installed it either needs to be installed on top of the metal eave drip edges per manufacturers installation guidelines, which are also most City Codes. Otherwise the ice and water shield has to cover the face of the fascia board and then the metal eve drip edge can be installed over it.

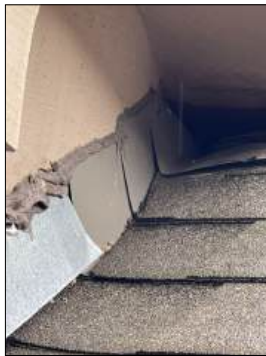
The kitchen area around brick structure on the north side does not have proper counter flashing at the top area in the lower galvanized counter. Flashing is not properly sealed and then the bottom step flashing above the eave does not have a kick out flashing and it is also not sealed properly. ** May need to fit trim to cover as well. **

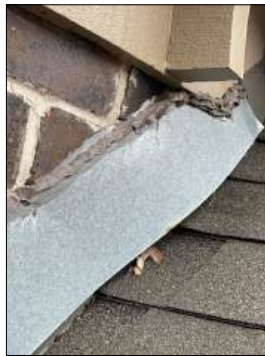
The kitchen area around brick structure on the north side does not have proper counter flashing at the top area in the lower galvanized counter. Flashing is not properly sealed and then the bottom step flashing above the eave does not have a kick out flashing and it is also not sealed properly.

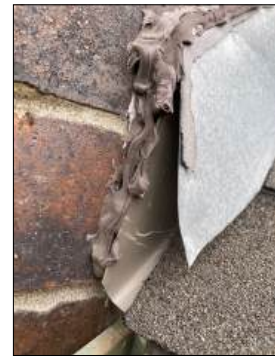
The kitchen area around brick structure on the north side does not have proper counter flashing at the top area in the lower galvanized counter. Flashing is not properly sealed and then the bottom step flashing above the eave does not have a kick out flashing and it is also not sealed properly.

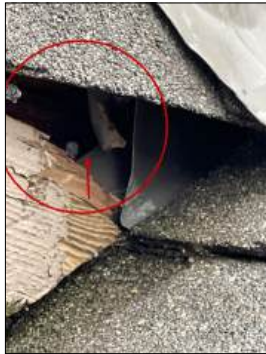
3.7. The kitchen round brick structure northside at the bottom of the valley there are openings above the flashing and also some wood damage that doesn't help. This needs to be properly flashed now.

The kitchen round brick structure northside at the bottom of the valley there are openings above the flashing and also some wood damage that doesn't help. This needs to be properly flashed now.

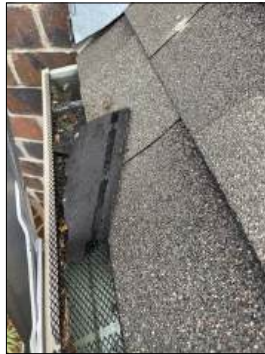
3.8. There is a shingle tab lying in the gutter above the kitchen roof area. It appears to have broken loose below the gutter area where there's flashing located.

There is a shingle tab lying in the gutter above the kitchen roof area. It appears to have broken loose below the gutter area where there's flashing located.

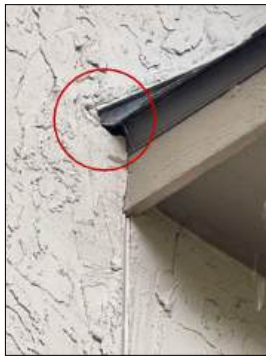
3.5. Missing Kick Out Flashing's need to be installed at: On the south side of the garage above the electric meter area. Use Stucco Repair Specialists.

Missing Kick Out Flashing's need to be installed at: On the south side of the garage above the electric meter area.

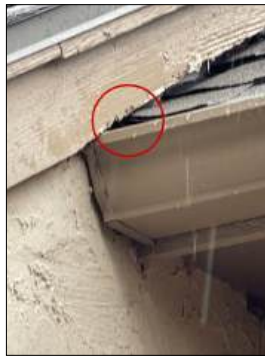
3.9. Missing roof kick out flashing on the west side at the north end of the gutter north of the chimney area. ** Braden Roofing **

Missing roof kick out flashing on the west side at the north end of the gutter north of the chimney area.

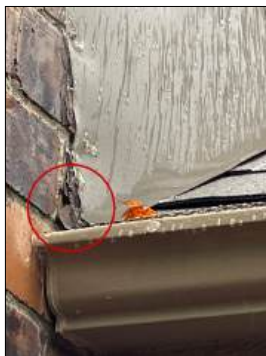
3.10. Missing roof kick out flashing on both sides of the chimney. ** Braden Roofing **

Missing roof kick out flashing on both sides of the chimney.

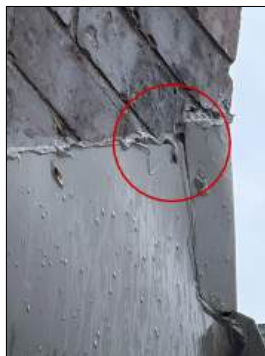
3.13. The metal roof flashing of course is attached to the surface of the chimney brick and the sealant along the top of the counter flashing will need to be checked every three years. ** There are areas now that need to be sealed **

The metal roof flashing of course is attached to the surface of the chimney brick and the sealant along the top of the counter flashing will need to be checked every three years. ** There are areas now that need to be sealed **

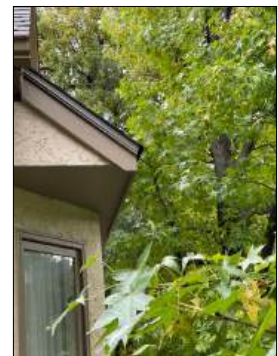
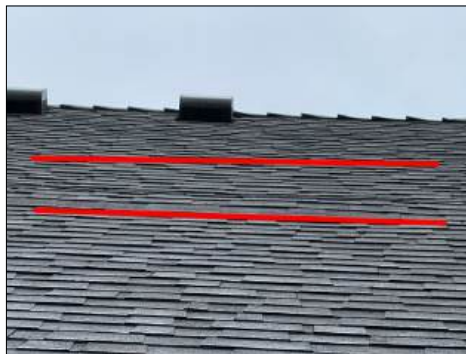
On the west side of the roof towards the southside center area is a raised/Humped Area of the roof surface. It is approximately 6 feet in length and approximately 2 feet high. This needs to be evaluated and corrected.

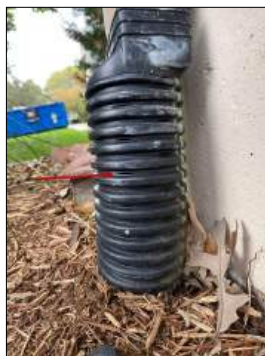
The downspout underground drain pipes are perforated/slotted and CAN'T be used for downspouts.

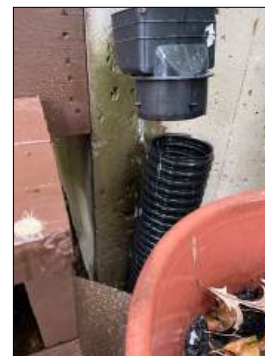
14.5. The far south west corner downspout has become disconnected from the underground drain pipe and is dumping water against the foundation. There should be a reducer that extends down into the underground pipe at least 8 inches to prevent this. The downspout should never be securely attached to the underground pipe.

The far south west corner downspout has become disconnected from the underground drain pipe and is dumping water against the foundation. There should be a reducer that extends down into the underground pipe at least 8 inches to prevent this. The downspout should never be securely attached to the underground pipe.

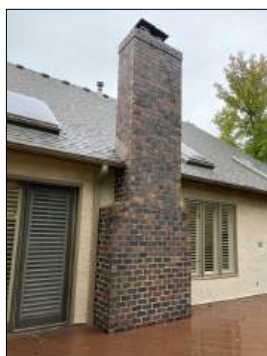
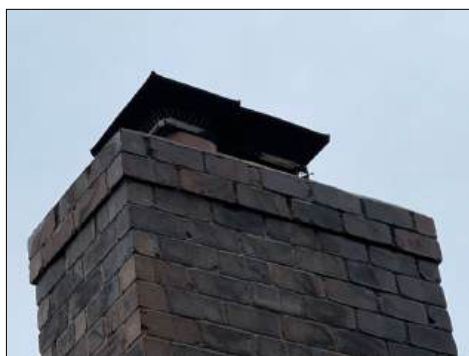
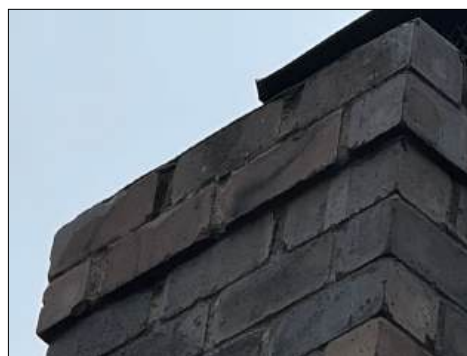
1.1. Brick Structure

The chimney top concrete crown should be skim coated in the top two rows of brick need some minor tuck pointing.

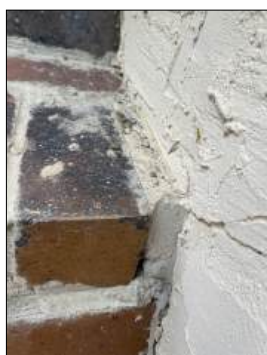
The brick chimney eyebrows need to be sealed with a brick meets the stucco and then down the vertical sides of the brick also needs to have new sealant applied.

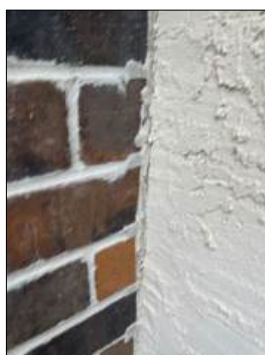
The brick chimney eyebrows need to be sealed with a brick meets the stucco and then down the vertical sides of the brick also needs to have new sealant applied.

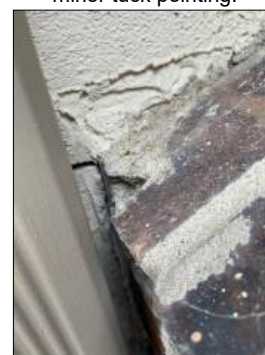
The brick chimney eyebrows need to be sealed with a brick meets the stucco and then down the vertical sides of the brick also needs to have new sealant applied.

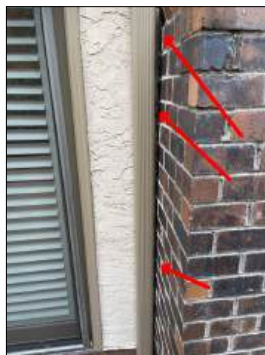
The brick chimney eyebrows need to be sealed with a brick meets the stucco and then down the vertical sides of the brick also needs to have new sealant applied.

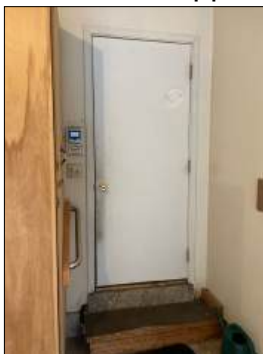
5.1. Need to install new door casement weatherstrips due to damage and/or current ones don't seat at the threshold and/or not properly fitted at the upper corners.

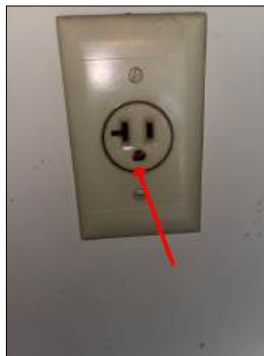
11.3. The garage West receptacle for an appliance has a broken ground plug in the socket.

The garage West receptacle for an appliance has a broken ground plug in the socket.

11.1. Need a Licensed Electrician to Evaluate the Electrical Safety & Defect issues noted.

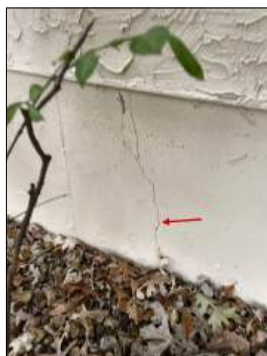
1.4. The southside foundation at the garage area has a couple of cracks which appear to be having some movement. The drainage is extremely bad along the side which causes issues with the foundation.

The southside foundation at the garage area has a couple of cracks which appear to be having some movement. The drainage is extremely bad along the side which causes issues with the foundation.

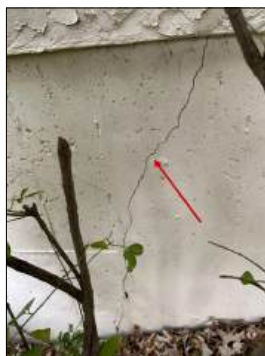
The southside foundation at the garage area has a couple of cracks which appear to be having some movement. The drainage is extremely bad along the side which causes issues with the foundation.

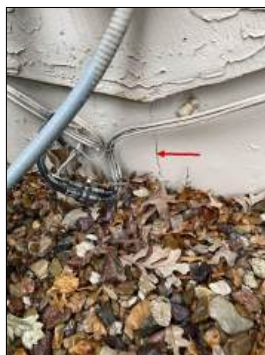
Foundation crack noted behind the air conditioning condenser.

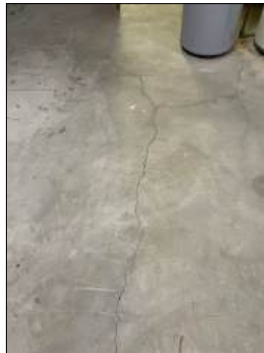
Typical slab cracking.

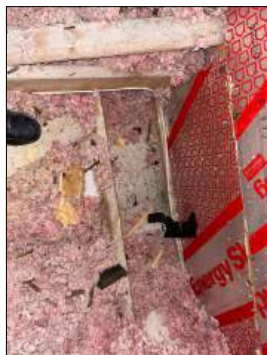
Visible ceiling drywall in a few areas where the ceiling joist are not covered with insulation. Need additional insulation. West of the garage area

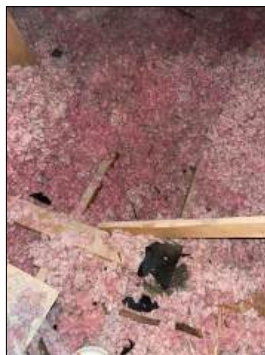
Exposed Ceiling Joists noted in several areas or throughout. This can cause Thermal Bridging which is when heat escapes into the cold attic space causing condensation issues. Recommend additional insulation to correct this. There needs to be insulation added now!

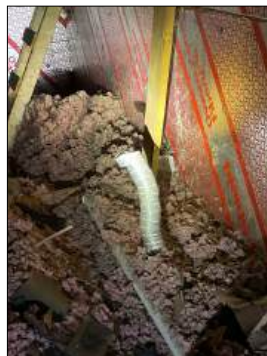
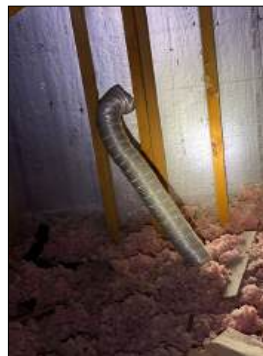
8.2. On the far south wall there is an exhaust hose that's pushed up against the exterior surfaces and needs to be redirected.

On the far south wall there is an exhaust hose that's pushed up against the exterior surfaces and needs to be redirected.

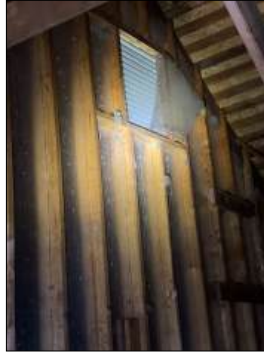
11.1. Vent screens are damaged or missing, suggest repairing or replacing screens as necessary. Birds and Vermin can enter the attic.

Vent screens are damaged or missing, suggest repairing or replacing screens as necessary. Birds and Vermin can enter the attic.

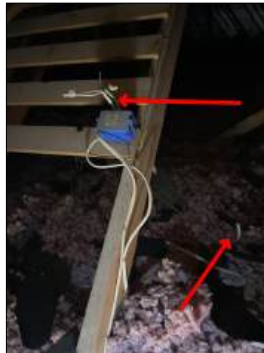
12.1. Exposed wiring connections sticking out of a junction box west of the garage area.

Exposed wiring connections sticking out of a junction box west of the garage area.

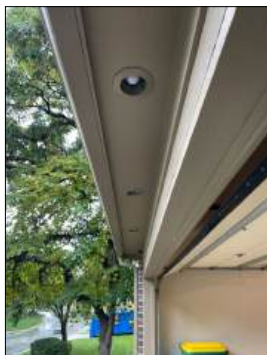
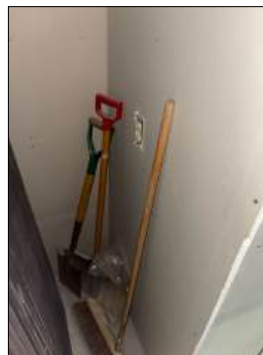
1.4. Missing or Damaged Receptacle Covers at: furnace room sw corner at the wet bar bump out

Missing or Damaged Receptacle Covers at: furnace room sw corner at the wet bar bump out

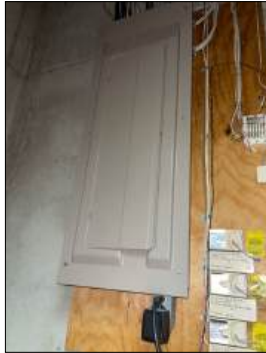
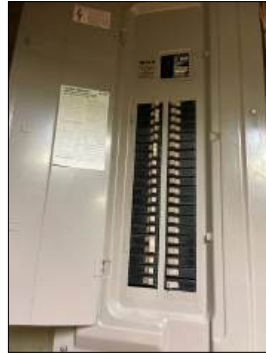
There are White Neutral Wires on the neutral bars that are tapped together with other neutral and or ground wires. All Neutral wires must be on their own terminal and can not be tapped together with other neutral or ground wires per National Electric Codes 408.21 or 408.41 and also refer to 110.3(B). You are allowed to twist 3 ground wires together and put them on one terminal to make room if needed.

1.3. Need a Licensed Electrician to Evaluate the Electrical Safety & Defect issues noted. Referrals: Teague Electric at 913-529-4600 or Tann Electric at 913-236-7337.

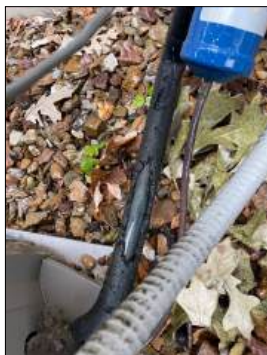
Exterior air conditioning refrigerant lines needs new insulation installed.

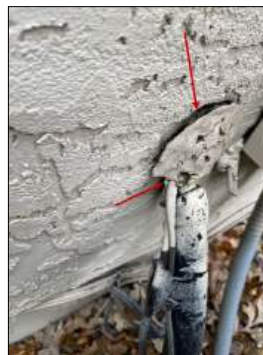
Need to seal up around the exterior air-conditioning refrigerant lines were enters the siding with Thumb Gum Sealant.

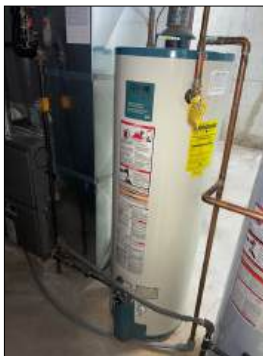
IPR Valve is upside down.

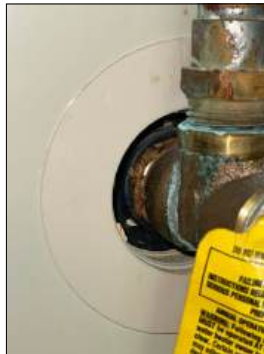
3.1. The TPR Valve is upside down!

The TPR Valve is upside down!

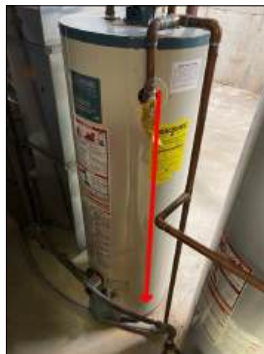
4.1. The TPR Valve Discharge piping installed is not allowed and need to install a properly approved Discharge pipe that stops 6" above the floor surface.

4.2. The water heater TPR Valve discharge pipes are not supposed to be connected together or connected to a hose extension running across the floor.

The TPR Valve Discharge piping installed is not allowed and need to install a properly approved Discharge pipe that stops 6" above the floor surface.

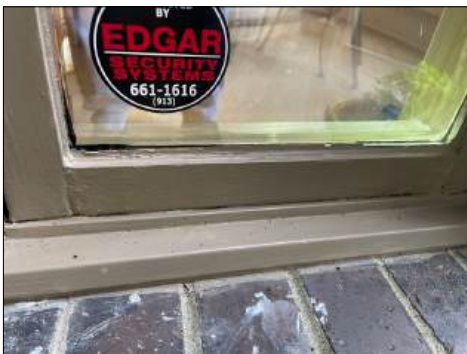
The kitchen breakfast nook bay windows, both of the south windows have rotted window extrusions and bottom window casement.

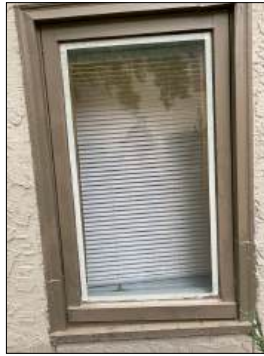
1.10. South side lower window west of the air condition condenser is in very poor condition. Brick molding has been patched in with sections, the window sags and there is a gap at the bottom.

Southside lower window west of the air conditioning condenser is in very poor condition. Brick molding has been patched in with sections, the window sags and there is a gap at the bottom.

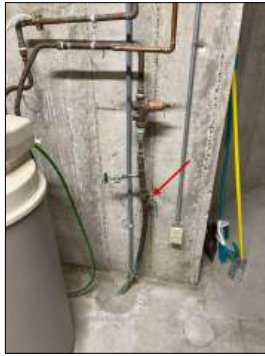
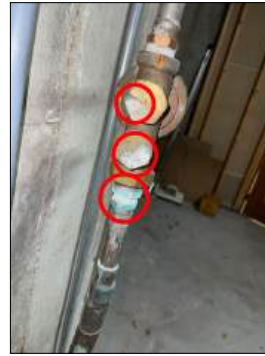
Evidence of corrosion at the pressure regulator and the pressure regulator connection

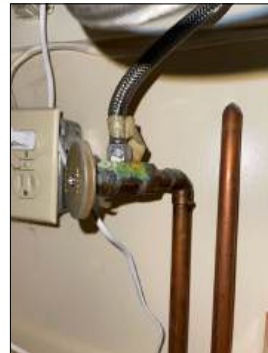
2.1. Evidence of a leak at the east sink drain line trap connection and wall drain connection as well as the hot water shut off valve.

Evidence of a leak at the hot water shut off valve

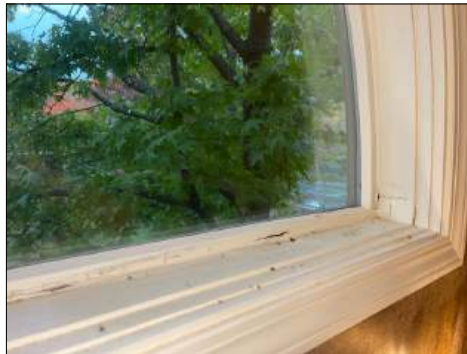
16.1. The picture window bottom interior casement and sill is rotted out

The picture window bottom interior casement and sill is rotted out

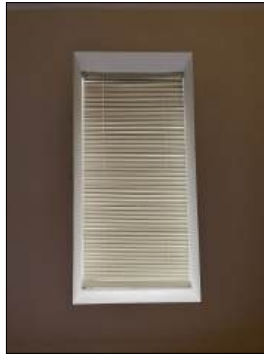
The skylight is covered with blinds and could not be inspected

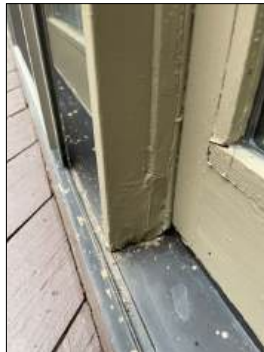
Water damage to the exterior vertical wood section between the opening door in the center stationary section.

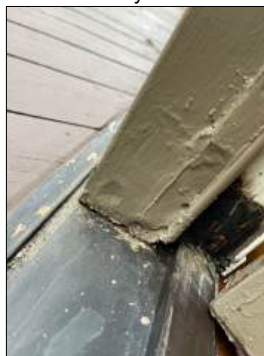
12.5. There is Water Damage at the Door Casement south side.

There is Water Damage at the Door Casement south side. The north side has been replaced

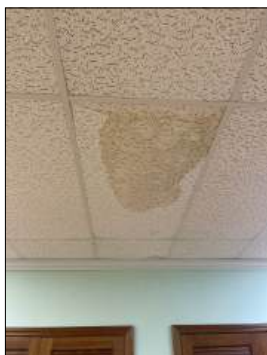
Evidence of Water Stains noted at: center of room

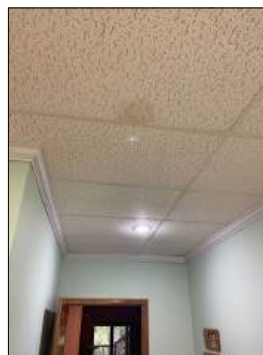
Evidence of Water Stains noted at: 5 panels inside of room from door

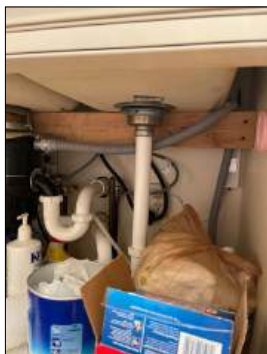
5.1. Dishwasher drain needs a proper **air gap** loop installed. The loop needs to be 8 inches higher than the drain connection. This is to prevent siphoning back into the dishwasher. Adjustment needed.

Dishwasher drain needs a proper air gap loop installed. The loop needs to be 8 inches higher than the drain connection. This is to prevent siphoning back into the dishwasher. Adjustment needed.

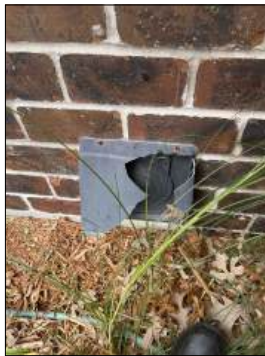
14.2. The exterior exhaust fan cover is damaged and needs to be replaced.

The exterior exhaust fan cover is damaged and needs to be replaced.

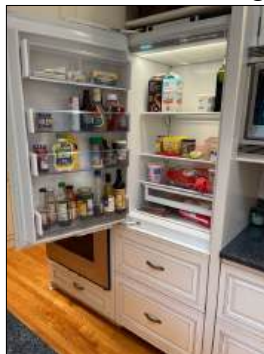
15.2. The upper freezer drawer rubs against the wood fridge door

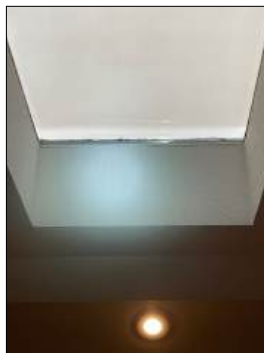
- 5.1. Evidence of Water Stains noted at: coming down from the top of the skylights. This seems to be from condensation on the windows as the stains are very light.

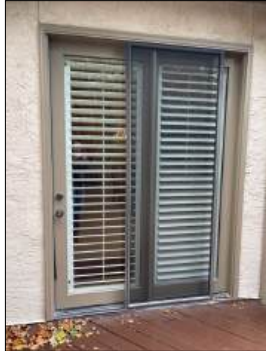
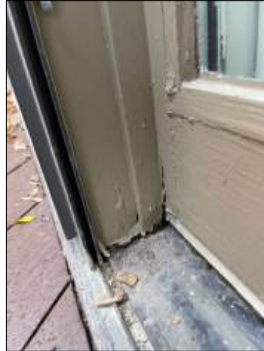
The exterior vertical divider between the main door in the station in the door has water damage.

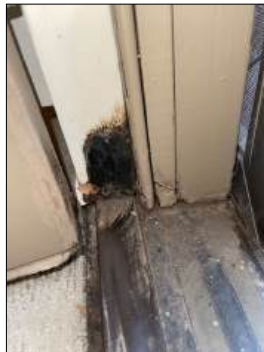
9.5. There is Water Damage at the Door Casement.

There is Water Damage at the Door Casement.

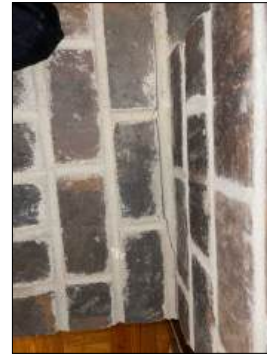
8.5. Hearth crack along the north end

Hearth crack along the north end

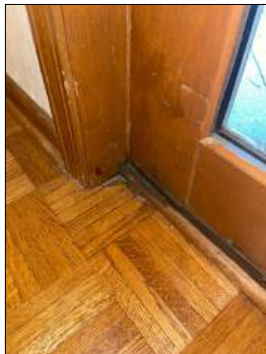
Water intrusion coming in at the south corner of the door where the casement has a gap at the weatherstrip that leads inside

9.3. Recommend sealing the casement with caulking to prevent further water intrusion and damage to the wood casement and flooring

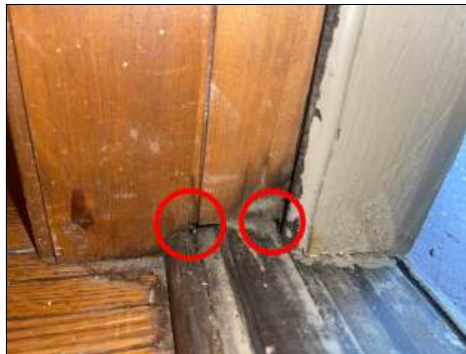
The casement has a gap at the weatherstrip that leads inside

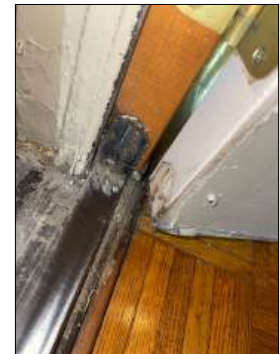
9.2. Evidence of water intrusion at the north end of the door casement

Evidence of water intrusion at the north end of the door casement

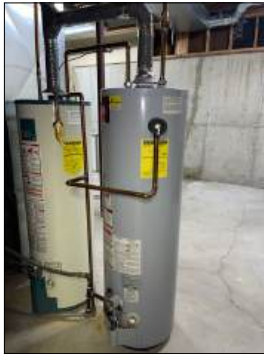
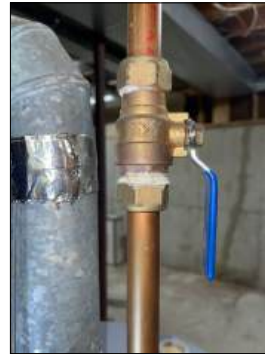
1.1. Evidence of a leak at the cold water shut off valve connection. Calcium build up, but not wet today. MONITOR.

Evidence of a leak at the cold water shut off valve connection

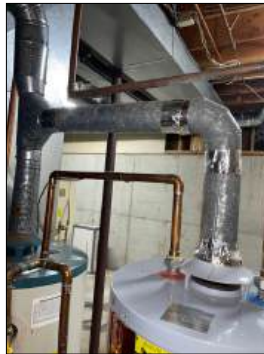
The flue from this unit to the connection above the west unit should have a slightly better slope for drafting. It was not showing any back drafting at this time. When the old water heater is replaced, it should be corrected at that time.

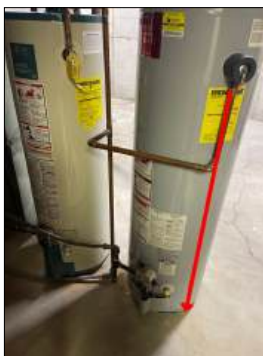
The TPR Valve Discharge piping installed is not allowed and need to install a properly approved Discharge pipe that stops 6" above the floor surface.
